# Accessibility audits of sites within the Causeway Coast and Glens Heritage Trust area

Improving access for disabled residents and visitors

Prepared by Direct Access Consultancy Limited  
Summer 2021

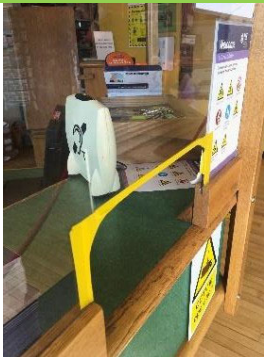
On arrival there was no hearing induction loop. This was found in storage and plugged back in and found to be working.	Implement a management procedure to keep the system in view of visitors and ensure that the correct signage is prominently displayed.

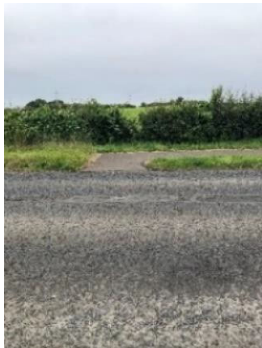
The footpath from the village to the field at the crossing point does not feature tactile paving. There is no dropped kerb on the entrance side of the road where the level pedestrian access is shared with vehicles and features a grate.	Site management should undertake liaison with DFI Roads to provide tactile paving in the area to aid people with impaired vision. The paving should be 'Buff' coloured in accordance with GOTP.	2	M

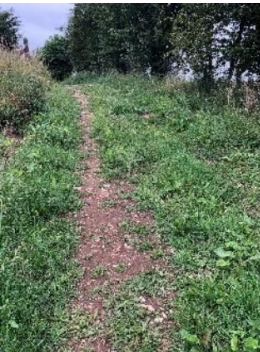
Third part of path becomes steeper downhill. Gradients are a hazard for disabled people particularly where surfacing is not accessible.	To make the path accessible the steeper gradients should feature correctly spaced Landings 1200mm W x 1500mm L dependent upon gradients over the entire route. No gradient to be steeper than 1:12.	3	E

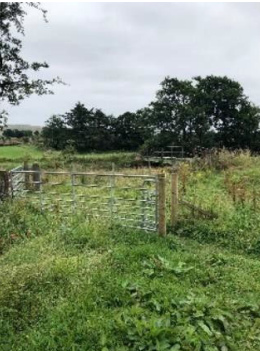
At the far end of the field there is a gate leading to a bridge.	It is unclear if this gate and the bridge beyond is to be included as part of an accessible multi-user route. The gate and associated footpath surface etc would require improvement to the same accessible standard if they were included on the route.	2	G

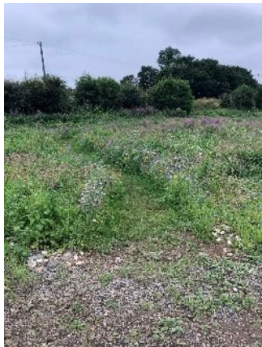
Footpath back towards car park. Grass with some uneven parts	To convert this route to an accessible walk an accessible surface 1800mm wide is recommended. To be accessible path surfaces must be compact, firm, non-slip and obstacle free. Suitable materials include concrete, tarmac, stone, timber and paving.	2	D

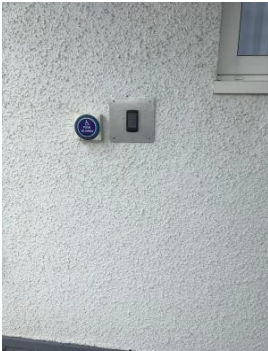
The push button is located too high for someone who may need to use their arm to push the button to activate the door.	Manual activation controls for power-operated pedestrian doors should be located at a height of between 750mm and 1000mm from finished floor level. In order to be clearly visible, they should contrast visually with the surrounding background.	2	A

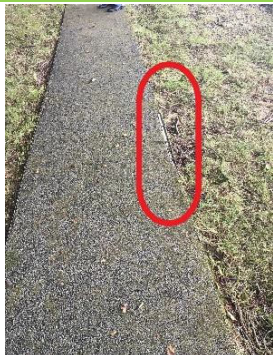
Part of the accessible path has eroded with metal supports exposed.	Advise site management of the defect and ensure that regular inspections of surfaces are carried out to provide a firm, level and slip-resistant over the entire length and width of all accessible routes.	1	M

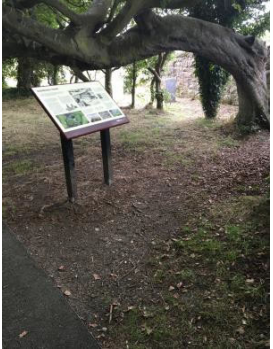
The interpretation panel is on uneven ground and not visible from the accessible path.	Interpretation panels should be located in visible areas that can provide a clear 1500mm x 1500mm approach over firm, level and slip-resistant surfaces that are directly connected to an adjoining accessible access route 1500mm wide.	2	B

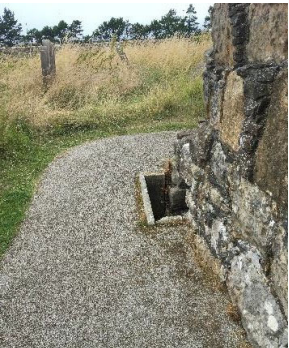
Unprotected drainage extrudes into the accessible path creating a trip hazard.	The drainage is a hazard for disabled people using the access route. The drainage should be covered or guarded.	1	A
-----	---	---	--	---	---	---

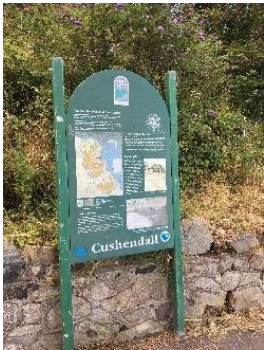
The interpretation panel does not provide any information for visitors with a visual or hearing impairment.	Many disabled people carry devices, such as Tablets and phones, that are customised to meet their personal access requirements. Providing interpretation through these devices is a great way of ensuring that disabled people have access to BSL, subtitles and audio information.	2	C

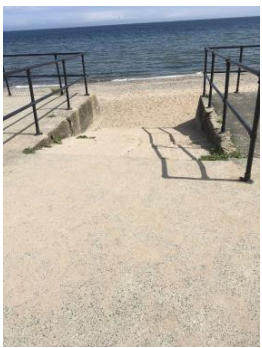
The Stepped Slipway is the most direct access route from the car park to the beach. The steps do not feature handrails.	BS8300 compliant handrails should be installed to both sides of the steps. These should be well contrasted and not cold to touch. The handrails should have a suitable profile (circular: 40 – 45mm, oval 50mm, in diameter). The handrail should be installed at a height of 900mm and should continue horizontally at least 300mm beyond the top and the bottom steps.	2	B

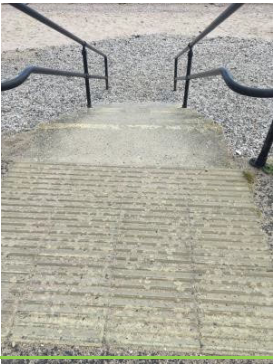
The step nosings are worn and not visible in some places.	The nosings of the steps are recommended to be repainted. The contrasting material should extend 50 mm to 65 mm in width from the front edge of the tread and 30 mm to 55 mm from the top of the riser and should contrast visually with the remainder of the tread and riser.	2	A

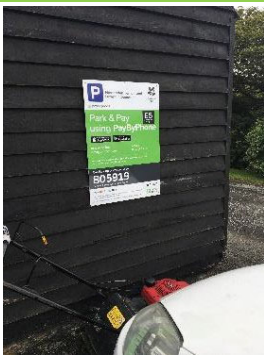
On arrival the hut is staffed. It was difficult for deaf people to communicate and understand the parking options.	Introduce disability awareness and basic BSL training for staff to indicate the key parts of the parking e.g. to download app and pay online.	2	B

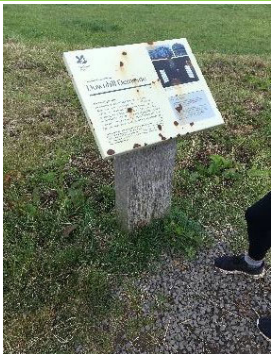
The interpretation panel is showing signs of wear and tear making it difficult to read.	Scheduled maintenance should be provided by the relevant authority to ensure that the panel is clean and legible.  This could be included in the ongoing interpretation refurbishment.	2	M

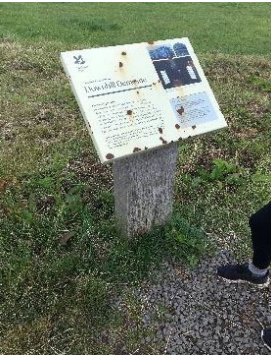
The approach to the front of the interpretation panel is of loose gravel that may be difficult for wheelchairs and people unsteady on their feet to use.	Interpretation panels should be located in visible areas that can provide a clear 1500mm x 1500mm approach over firm, level and slip-resistant surfaces that are directly connected to an adjoining accessible access route 1500mm wide.	3	B

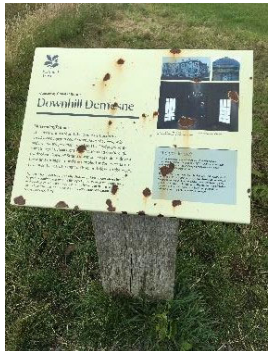
The interpretation panel does not provide access to information in Braille or audio format for visually impaired visitors information in sign language for Deaf visitors.	Many disabled people carry devices, such as Tablets and phones, that are customised to meet their personal access requirements. Providing interpretation through these devices is a great way of ensuring that disabled people have access to BSL, subtitles and audio information.	2	C

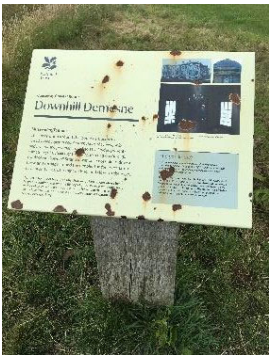
The interpretation panel does not provide access to information in Braille or audio format for visually impaired visitors information in sign language for Deaf visitors.	QR codes can be added to provide access to interpretation panels. Dynamic QR codes should be used because they can be edited. QR codes should be prominently displayed and advertised to visitors.  	2	C

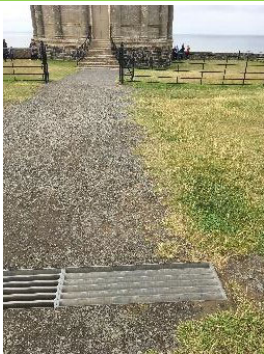
The grate on the approach to the Temple has gaps that may pose issues for wheelchairs and people unsteady on their feet.	Grates for drainage can cause difficulty for wheelchair users and people using sticks and crutches. The grate should be removed if possible or replaced with a grate with maximum slot widths 13mm wide at right angles to the direction of travel or circular holes no more than 18mm diameter	2	B

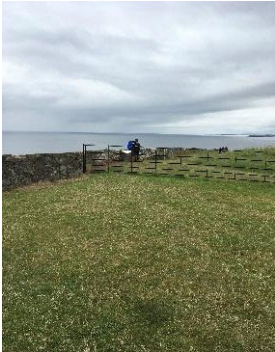
An interpretation panel overlooks the sea and cliff which is accessed by walking around the fence. Handrails can be used to provide Braille interpretation.	Consider using Braille on handrails to provide alternative accessible interpretation. For reference see <a href="https://www.news18.com/news/buzz/braille-inscription-railing-naples-castle-wall-italy-scenic-view-blind-people-4068731.html">https://www.news18.com/news/buzz/braille-inscription-railing-naples-castle-wall-italy-scenic-view-blind-people-4068731.html</a>	3	B

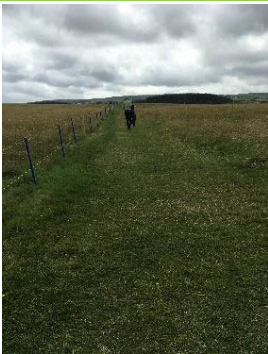
There is no signage to indicate that this is the recommended path or an alternative accessible path.	Waymarking signage should be present to include destination, distance, walk-time and any information regarding gradients, steps, alternative accessible routes, rest-points and view-points.	2	B

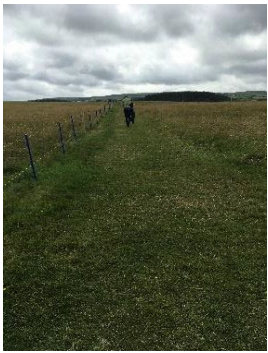
No seating is available on the route from the Temple to the Dovecot.	Resting points should be provided no more than 100m apart and should be placed clear of access routes with seating and tactile cues.	2	C

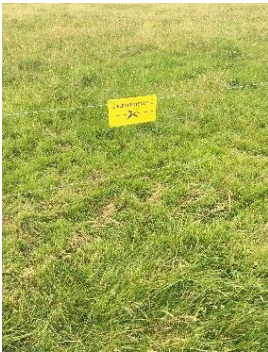
Warning signs of an electric fence were small and did not have sufficient contrast to the field beyond.	<p>The yellow safety signs on the green background of the field do not offer good contrast. Recommend adding a red background that can provide better contrast.</p>

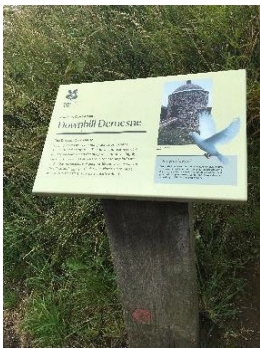
The interpretation panel does not provide access to information in Braille or audio format for visually impaired visitors.	Many disabled people carry devices, such as Tablets and phones, that are customised to meet their personal access requirements. Providing interpretation through these devices is a great way of ensuring that disabled people have access to BSL, subtitles and audio information.	2	C

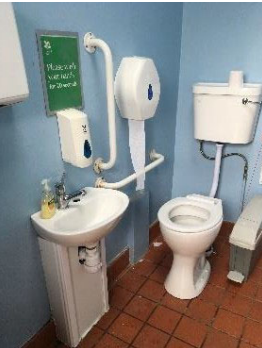
A vertical grab-rail should be present to both sides of the handbasin.	Grab rails should be provided either side of the washbasin. Where possible, vertical support bars at least 600mm long should be fixed each side of the washbasin, with their mid-point at 1100mm above the floor.  Refer to TB R & BS8300 for guidance.	2	A

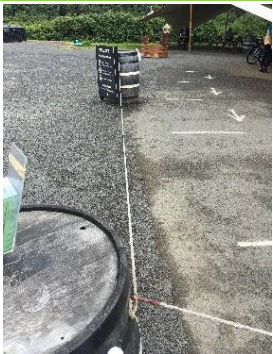
The rope barriers feature a flexible barrier at a single height only. A single height barrier may not be detected by the sweep of a cane and can allow guide dogs to go beneath causing a hazard for Blind and partially sighted people.	It is often easier to fill the void beneath barriers with signage, seating, planting or similar that will provide guarding at a low level.	2	M

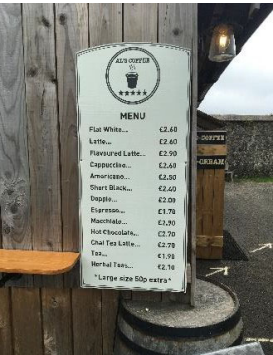
Café menu is text based.	A pictorial menu will enable deaf visitors and visitors with autism to identify and request what they would like to order.	3	A

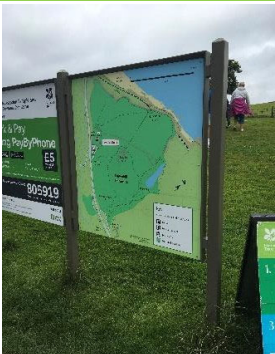
The map indicates that there are male and female restroom facilities. By omission of the wheelchair symbol it implies there is no accessible restroom. The signage is in need of a site wide review.	The signage should be replaced as part of a site wide integrated and consistent signage scheme. Any new signage scheme should follow best practice in include recognised symbols, good contrast, lettering, text and layout that is easy for everyone to read and complies with clear-print and signage guidelines.	2	C

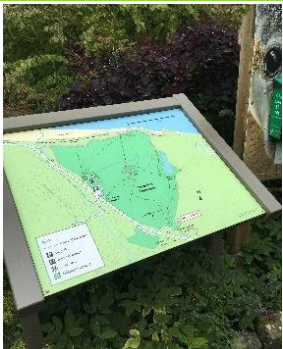
The map indicates that there are male and female restroom facilities. By omission of the wheelchair symbol it implies there is no accessible restroom.	The signage should be replaced as part of a site wide integrated and consistent signage scheme. Any new signage scheme should follow best practice in include recognised symbols, good contrast, lettering, text and layout that is easy for everyone to read and complies with clear-print and signage guidelines.	2	C

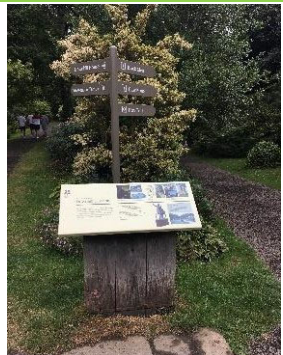
The interpretation panel does not provide access to information in Braille or audio format for visually impaired visitors.	Many disabled people carry devices, such as Tablets and phones, that are customised to meet their personal access requirements. Providing interpretation through these devices is a great way of ensuring that disabled people have access to BSL, subtitles and audio information.	2	C

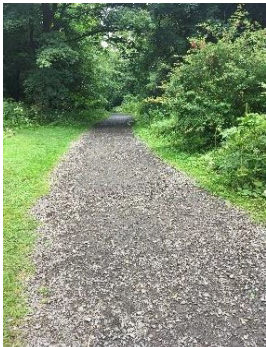
No seating is available on the route.	Resting points should be provided no more than 100m apart and should be placed clear of access routes with seating and tactile cues.	2	C

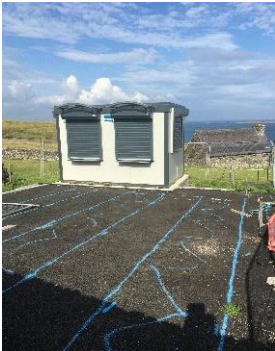
<p>The new counter does not appear to feature a hearing induction loop for hard of hearing visitors.</p> <p>BS8300 - A hearing enhancement system, using induction loop, infrared or radio transmission, should be installed at service or reception counters where the background noise level is high.</p>	<p>Install an induction loop to the reception desk. Install signage indicating the availability of the facility and ensure that staff members are aware in how to use the system.</p> <p>Direct Access has its own bespoke desk induction loop Please see here <a href="https://directaccessgp.co.uk/induction-loops-and-hearingenhancement-systems/">https://directaccessgp.co.uk/induction-loops-and-hearingenhancement-systems/</a></p>	1	A

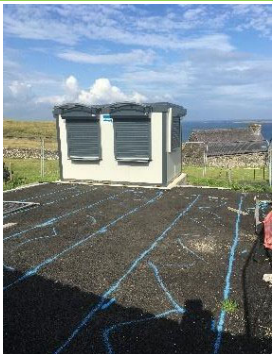
The ticket office is due for a replacement. The new service counter provided must be accessible to disabled people.	The counter should be designed to accommodate both standing and seated customers with at least one section of the counter 800mm wide, with its surface no higher than 760mm, and a knee recess 500mm deep up to a height of 700mm.	1	G

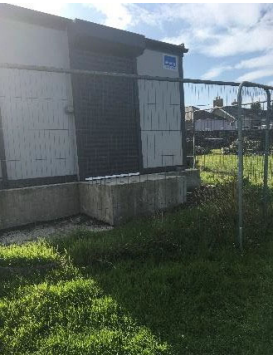
The entrance at the rear is stepped which would be difficult for any member of staff or volunteer with a mobility impairment.	Any new ticket office provided should incorporate level access for disabled people.	1	G

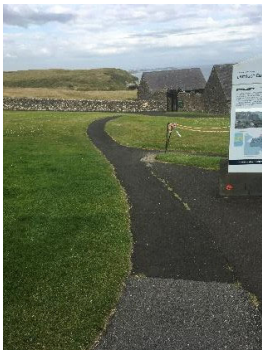
The access routes in some areas are particularly steep. This can cause significant difficulty for ambulant disabled people and wheelchair users.	Consideration should be given to providing handrails to one side of the steepest access routes. Subject to heritage constraints, any handrail installed should provide the required 300mm horizontal landing extensions with the entire handrail located at a height of 900mm from the slope and landing surface. Handrails should be coated with nylon or a suitable alternative to ensure that they are not cold to touch.	3	C

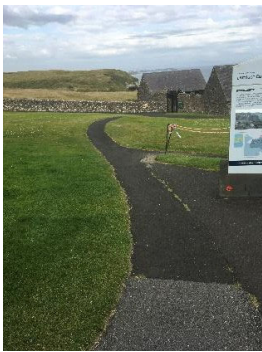
There is limited seating provided on all of the access routes resulting in limited resting opportunities being available for disabled people.	Seating is recommended to be provided at 50m intervals on access routes on firm and level ground and should not reduce the width of any access any access route. Where seating is provided it should be to the accessible standard given below.	1	B

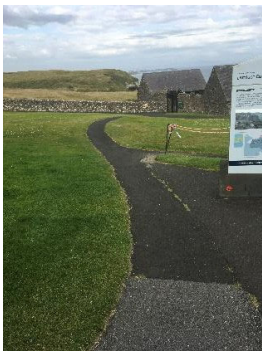
There is limited seating provided on all of the access routes resulting in limited resting opportunities being available for disabled people.	<ul style="list-style-type: none"> <li>1) There should be a variety of seat heights, ranging from 380 mm to 580 mm, within which a height of 480 mm is suitable for wheelchair users.</li> <li>2) Armrests should be provided to help people lower themselves onto the seat and stand up.</li> <li>3) Where the seat is set at a height suitable for wheelchair users, armrests should not be set in so as not to restrict the lateral transfer from a wheelchair</li> <li>4) A supportive back-rest should be incorporated for at least 50% of the length of the seat.</li> </ul>	2	B

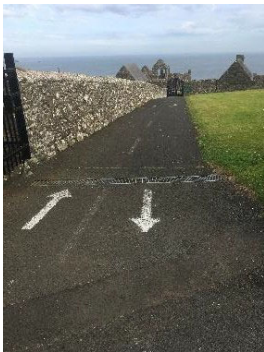
The wider access route provides a more accessible route from the car park area.	Signage should be used to direct visitors to this more accessible route from the car park.	1	A

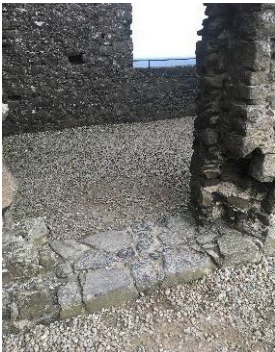
There are instances where ruins present permanent obstructions on access routes that can be a particular hazard for Blind and partially sighted people.	Subject to heritage constraints these obstructions on access routes should be highlighted by using contrasting nosings or signage.	3	M

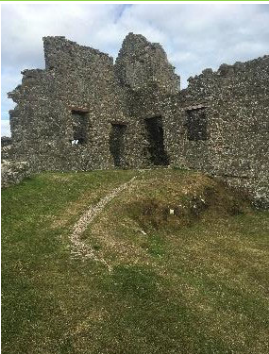
Steep access routes are present at the site that provide the only access to some popular areas.	Subject to heritage constraints, consideration should be given to providing wooden TB R compliant steps and handrails to improve access to these areas.	2	C

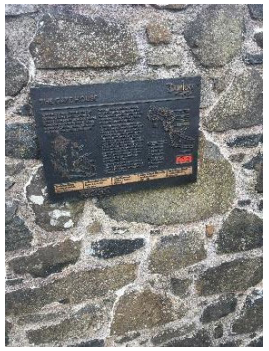
Staff explained that these are old signs and that the audio tours indicated no longer exist. This may be confusing to deaf people thinking they may be missing out or visually impaired people looking for an audio description of the site.	The presence of audio-tours is important for everyone and particularly for Blind and partially sighted people. The audio tours indicated should be recommissioned and made available. In the short-term signage should state that the audio-tour is no longer available.	1	B

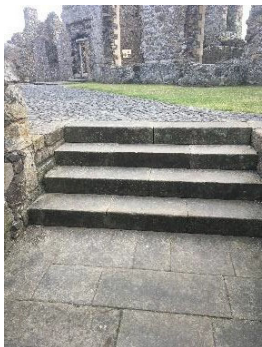
151.	Dunluce Castle / Steps

Handrails are not present. It is noted that the status of the building may prevent the installation of compliant handrails. Improvements should be considered over the long-term as opportunities arise.	Subject to heritage constraints BS8300 compliant handrails should be installed to both sides of the steps. These should be well contrasted and not cold to touch. The handrails should have a suitable profile (circular: 40 – 45mm, oval 50mm, in diameter). The handrail should be installed at a height of 900mm and should continue horizontally at least 300mm beyond the top and the bottom steps.	3	B

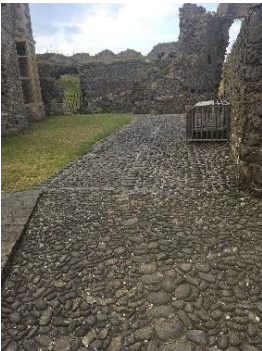
Cobbled surfaces are not considered accessible for disabled people.	Subject to heritage considerations consideration should be given to providing a 1200mm width smooth, level and slip-resistant surface underfoot.	3	C

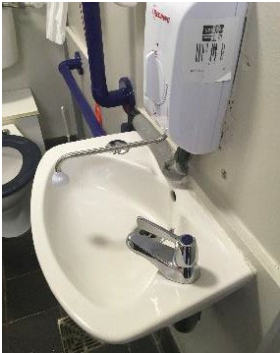
The lever tap appears to be for cold water and hot water comes from the white unit. The turn dial on the unit may not be accessible for visitors with dexterity impairments.	The different taps should be replaced with lever style or mixer, this will aid people with limited dexterity in their wrists.  According to BS8300 - Taps should either be mixer taps with an up and down action to control water flow or individual hot and cold lever operated taps with not more than a quarter turn from off to full flow.	2	A

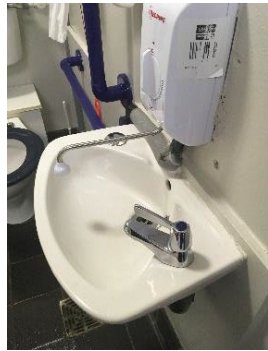
A vertical grab-rail is only present to one side of the handbasin.	Grab rails should be provided either side of the washbasin. Where possible, vertical support bars at least 600mm long should be fixed each side of the washbasin, with their mid-point at 1100mm above the floor.  Refer to TB R & BS8300 for guidance.	2	A

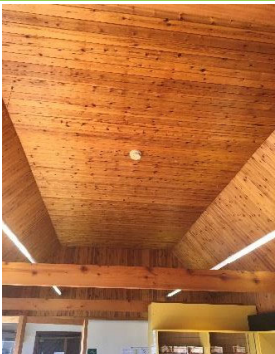
The visitor centre does not have a visible alarm beacon or strobe for deaf and hard of hearing visitors.	A suitable method of warning should be provided where one or more persons with impaired hearing are anticipated. This method is ideally by providing visual alarm warnings or it can be managed by allocated personnel and management systems.	2	A

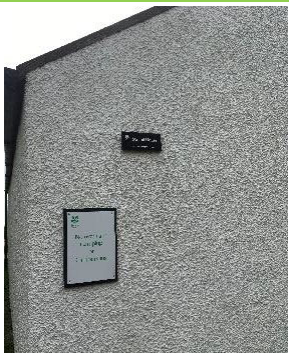
Signage such as this for Strand House is small and difficult for people to see.	Text height should be enlarged according to content and reading height. For large identification signs an 'X' height of 150mm is recommended with an absolute minimum 'X' height of 25mm at a 1m reading distance.	3	B
