Report on Restoration Potential for Altikeeragh Blanket Bog ASSI.

April 2023

Raymond Flynn, School of Natural and Built Environment, Queen's University Belfast.

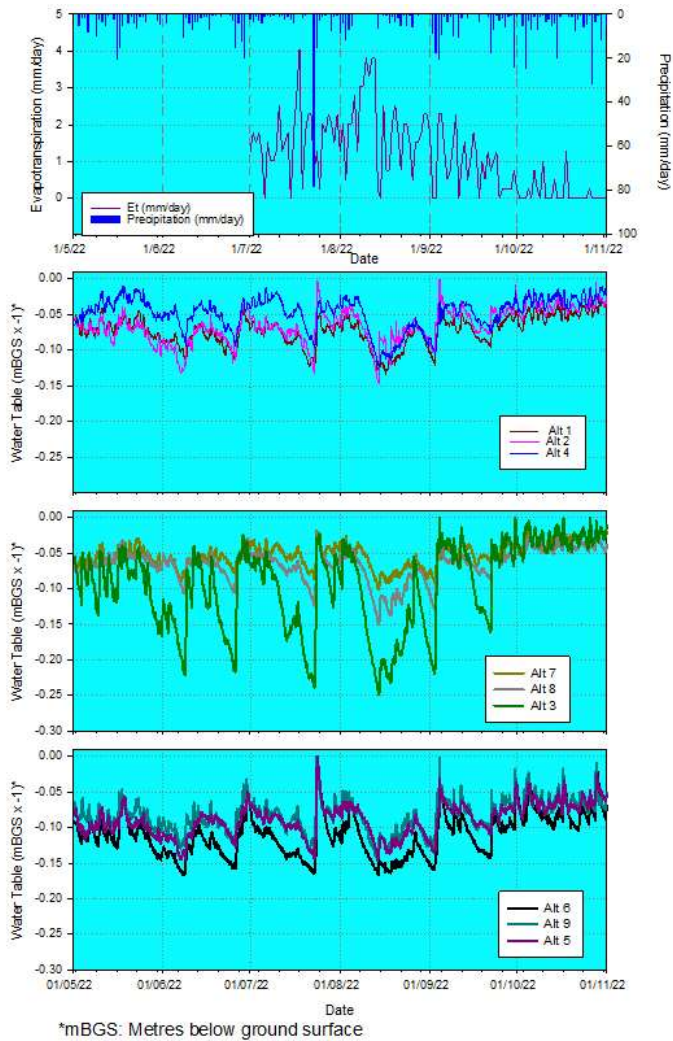
Figure 4: Rainfall, evapotranspiration and groundwater level fluctuations for Altikeeragh Blanket Bog, ASSI 1st May 2022 to 1st November 2022. Note: mBGS-metres below ground surface.

Figure 4 summarises water levels fluctuations for the summer and early winter period of 2022 and reveals a strong relationship between precipitation and groundwater levels. Critically frequent rainfall helps maintain the elevated groundwater levels, which can drop significantly during drier periods, particularly in the vicinity of drains. The range of water level fluctuations varies substantially, with the range of fluctuation proving greatest at Location 3 and Location 8, where the piezometers occur immediately adjacent to a drains containing little infilling vegetation. These contrast with background conditions at Location 7 and Location 4, where the impacts of drains are

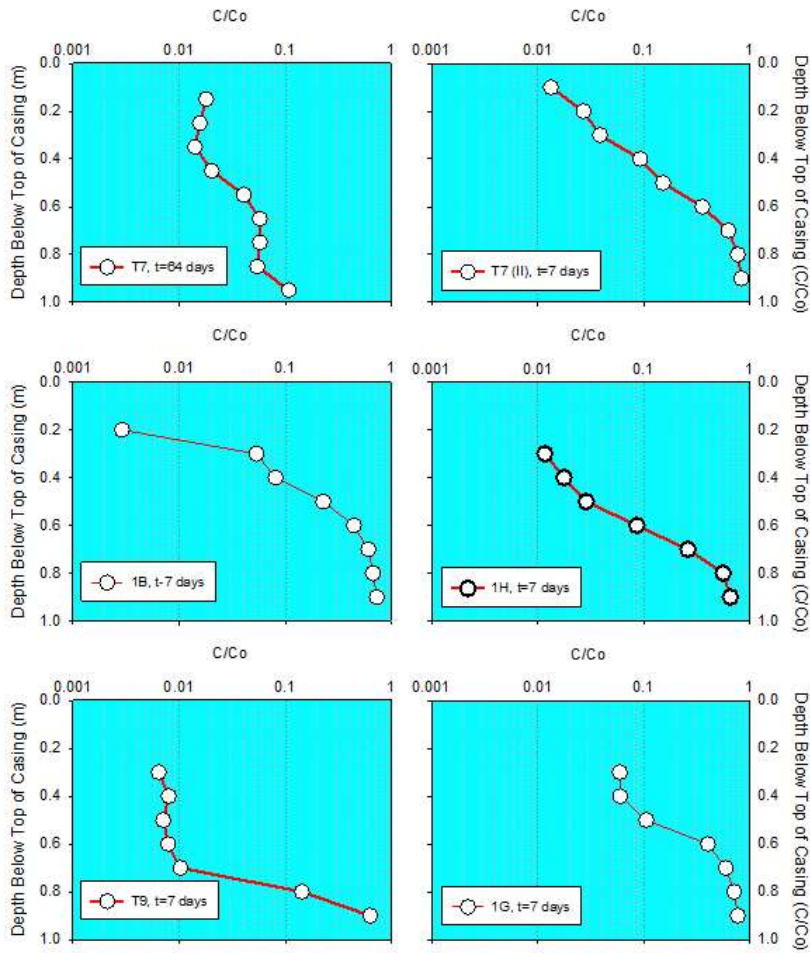
Figure 6: Results of tracer dilution tests(27 Jan 2023 to 3 Feb 2023) at selected monitoring wells, Altikeeragh ASSI. Note the logarithmic scale on the X-axis reflecting the more rapid loss of tracer (and greater groundwater flow rates) in the uppermost parts of the peat. Peat from this shallower part of the bog should not be used for peat dams in restoration works.

Figure 6, presenting the results of the testing, show that following the injection of tracer significant declines in concentration were observed at all locations over a relatively short time period. However, further examination reveals that concentrations increase with depth, indicating that water flowed faster closer to the ground surface.

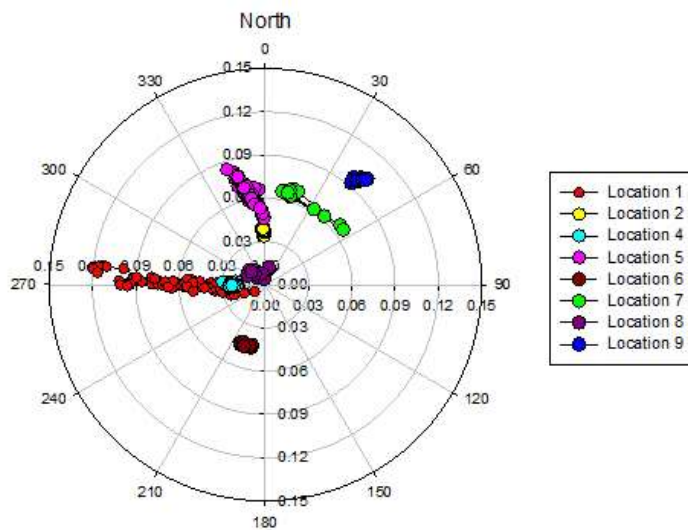
Figure 7: Variation in hydraulic gradient at hydrogeological monitoring points, Altikeergh ASSI. The magnitude of gradient proved greatest at Location 1 and Location 5, both of which are located within 2m of active drains.

Further examination of the hydraulic gradient across the test locations (Figure 7) revealed that with the exception of wells located immediately adjacent to drains, the magnitude of hydraulic gradient does not vary significantly (although the direction of flow does vary substantially at the control location).
