# Proposals Paper

for  
RAF Limavady Trainer Dome

Binevenagh and Coastal Lowlands Landscape Partnership Scheme

Hamilton Architects | August 2019

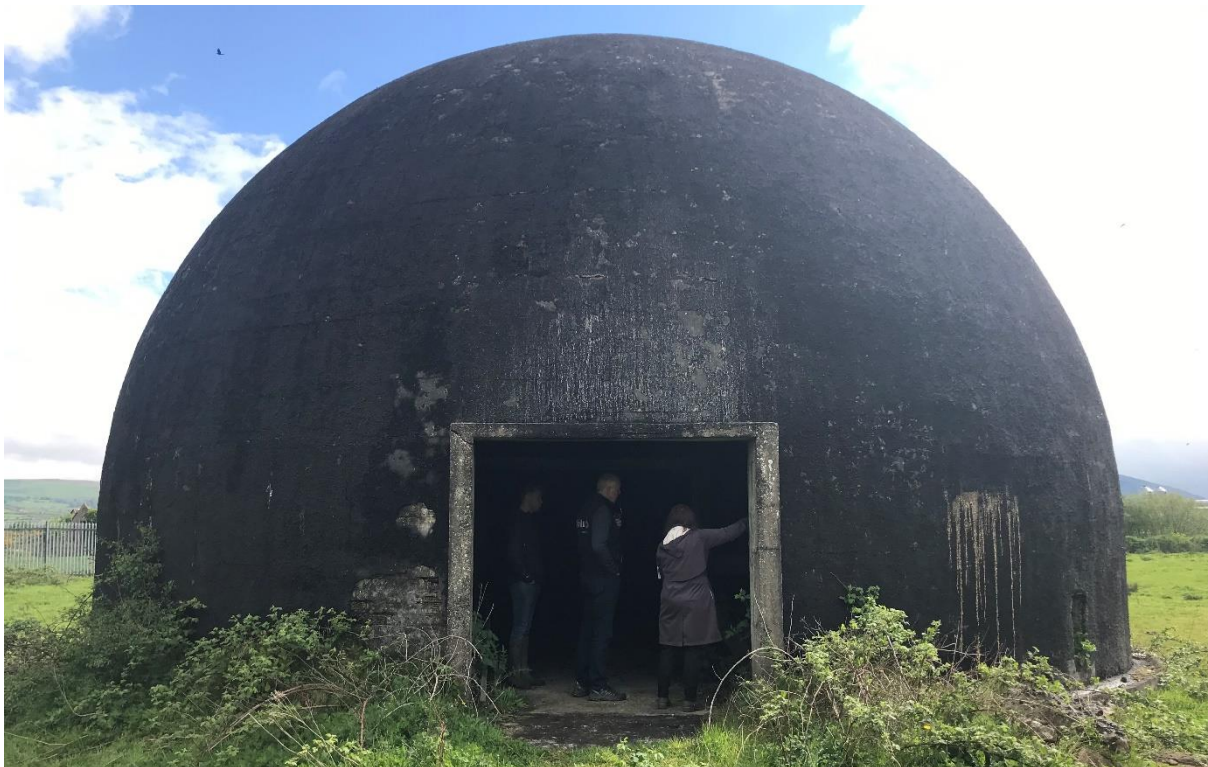
Figure 1 - The RAF Training Dome from the west – 31/05/2019

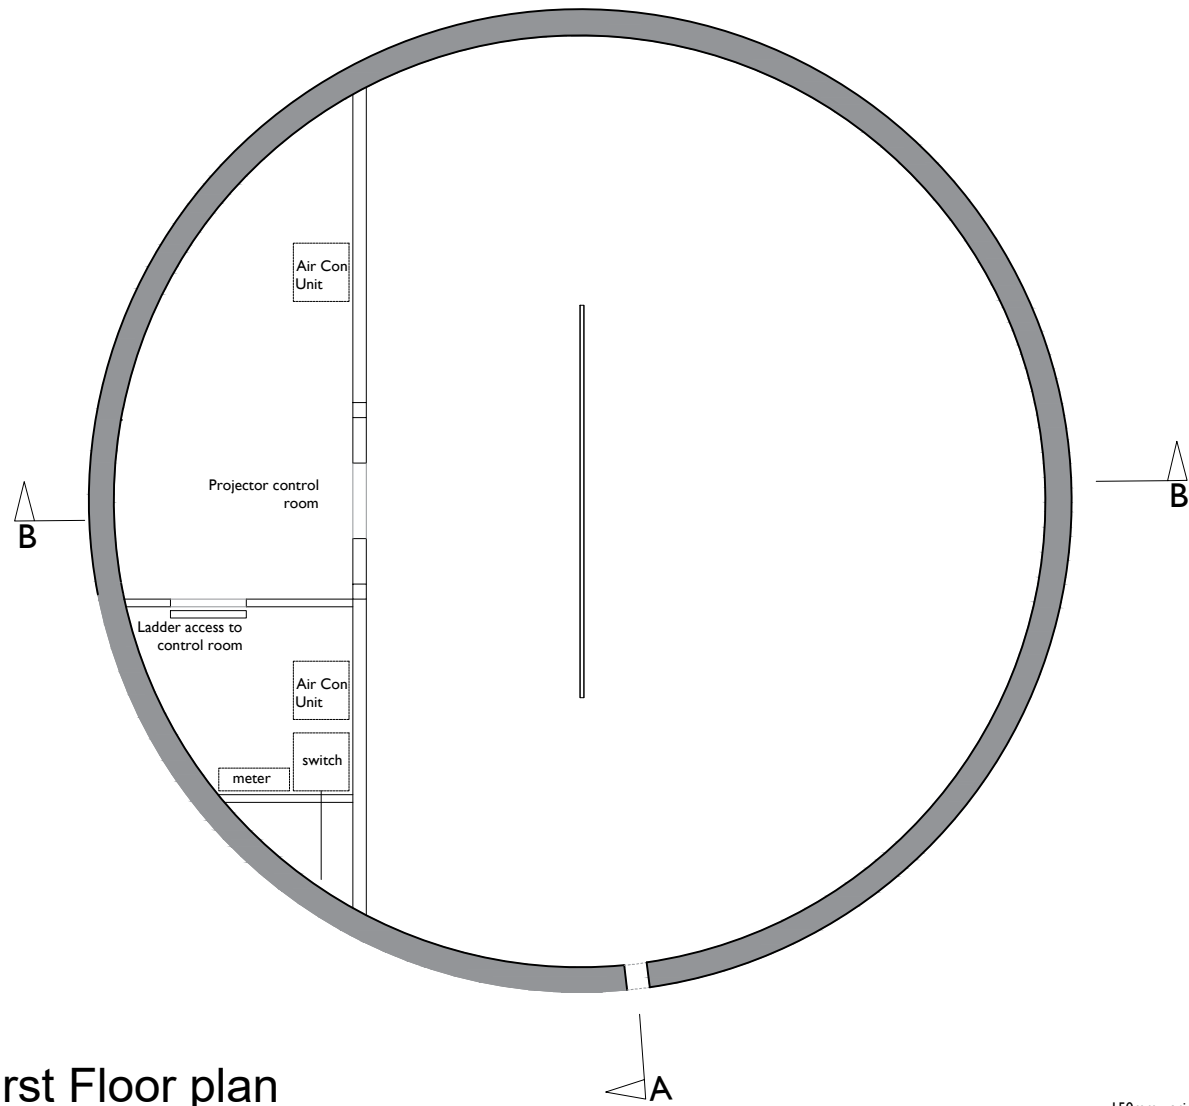
First Floor plan

New metal stud partition wall system (to reach o/a height of 7.6m high)

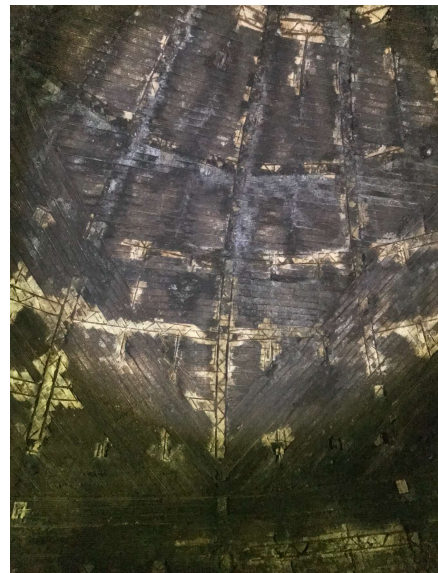
IMG\_6035

5.2.4 The loss of all the internal cover due to corrosion of the steel reinforcement has exposed not just the metal lathing but also significant areas of the ribs and hoops of reinforcement (IMG 6035 and IMG 6038). All the main steel reinforcement and lathing we looked at internally were corroded.

5.3.5 The repair of the internal part of the reinforced concrete dome is more challenging. The cover is lost and all the lathing and main reinforcement visible are corroded. Clearly a system of patch repairs is not applicable, and the cleaning and reinstatement of all reinforcement is probably ineffective. The thickness of the RC dome minus the lost internal cover is approximately 140mm, and the lost cover was measured to be between 15 and 20mm. Probably the most feasible option, from a buildability point of view, would be to use sprayed concrete to reinstate the internal part of the dome. That can be formed by shotcrete or gunite (sand-cement mortar) and carefully treated to provide a smooth finish. Within the internal concrete layer, we could incorporate fibre reinforced polymer strips attached to the internal surface of the dome. Although trying to avoid an increased
