Giant's Causeway

Trial Report

February 2024

Coin removal trials

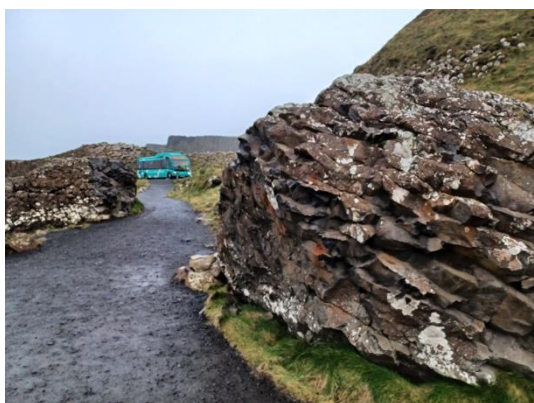
Fig.1 – General view of the boulders.

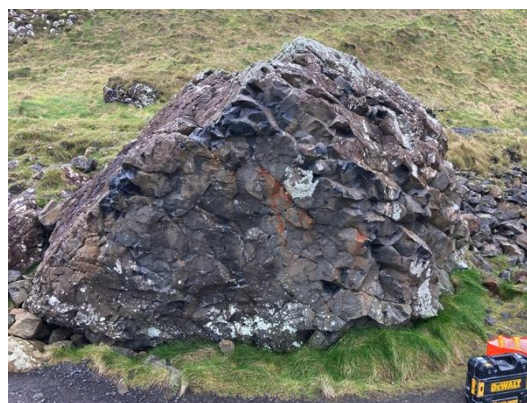
Fig.2 – The boulder the trials were carried out on.

This was a small-scale trial to determine what might be possible, what might work and what could be discounted as options, therefore a series of joints amounting to approximately 1.0 linear meter were worked on.

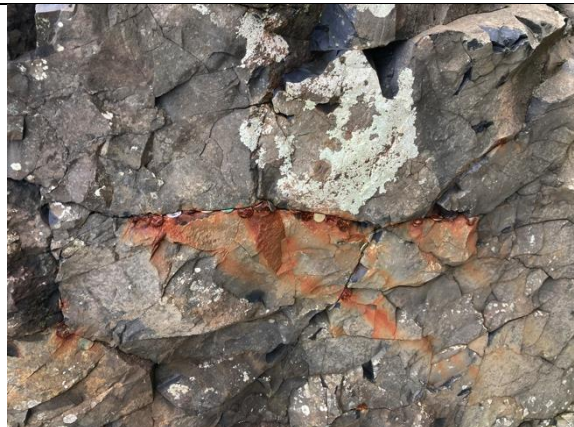
Figure 1 – Area 1 – Before

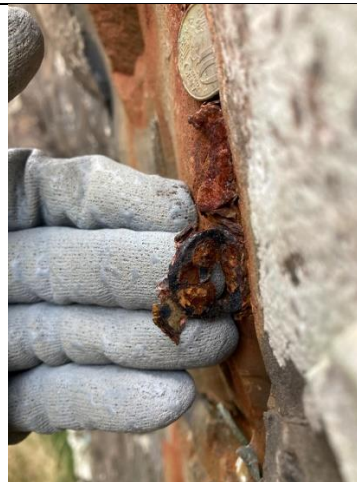
Copper that is corroding with a green colour, which is unsightly, but not expanding, and iron, which are causing ferrous staining and has the ability to expand and potentially damage the stone.

Figure 2 – Area 1 – Detail showing the condition of the coins in this area.

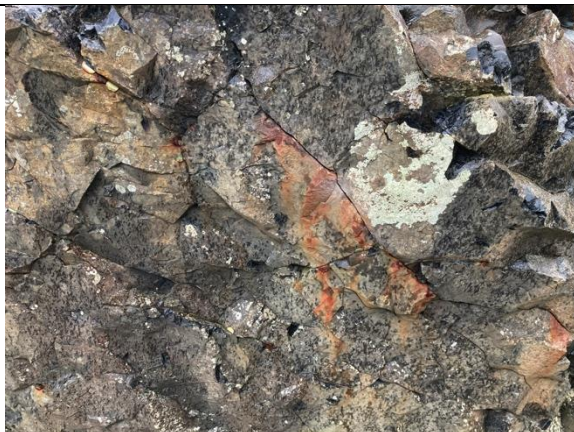
Figure 3– Area 1 – After

The coins in 1.0 linear metre took approximately 45min to remove, while carrying out these trials.

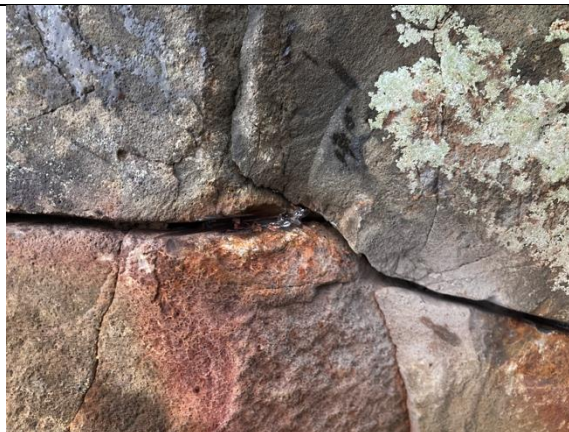
Using the variety of methods, the removal of the coins was 90% successful. Some were too well compacted and deep within the cracks to remove without causing damage to the stone.

Figure 4 – Area 1 – Detail showing compacted metal, which was drilled and cut out.

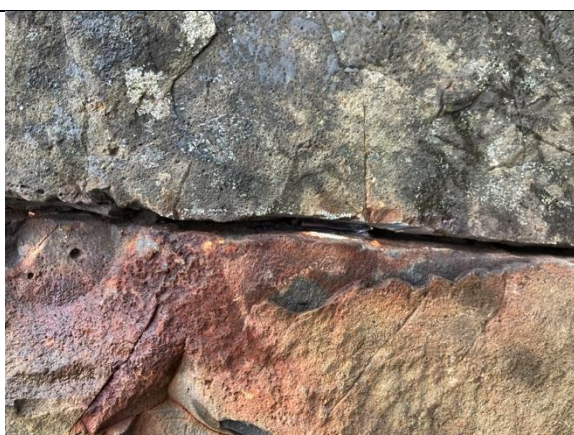
Figure 5 – Area 1 – Detail showing slight abrasion on the stone from battery powered rotary tool

Method		Effect on stone
Pliers, "needle nosed"	Gripping and pulling the coins out. Where the coin was bent over a piece of timber/softening was used to lever, bend and pull the coin out.	No damage to stone.
Chisels (3, 5, 10mm) and small carving hammer	Knocking the coin gently along its edge to spin or rotate it loose enough to pull out with fingers of pliers.	No damage to stone
Punches and small carving hammer	As above.	No damage to stone
Battery powered rotary tool (i.e. Dremmel) with 1mm blade	Cutting into corrosion or the coin itself.	Some abrasion to the stone if it slipped off the corrosion or coin. This could be effective in cutting 'relief' cuts in areas of thicker corrosion or compact/multiple coins pushed in to allow for chopping out of the coins.
Battery powered drill with thin drill bits	Drilling into corrosion or into coins that had broken off deeper within the joint	As above.
Hand held hacksaw blade with holder	This helped to loosen and spin some coins, but wasn't effective in cutting corrosion.	Some abrasion to the stone.

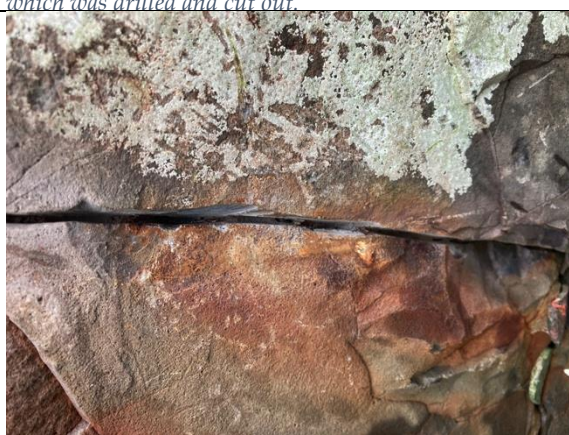
Figure 6 – Area 1 – Detail showing abrasion on the stone from battery powered rotary tool

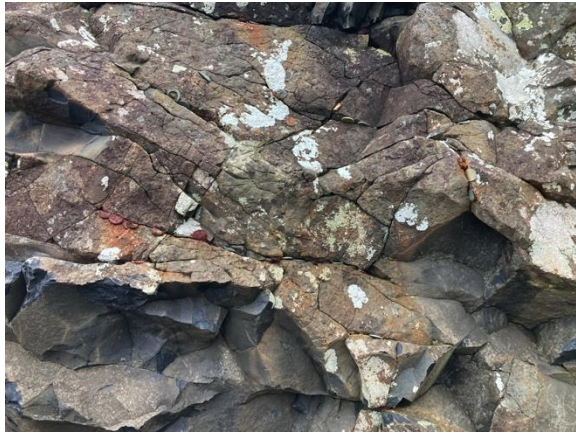
Figure 7 – Area 2 – Before

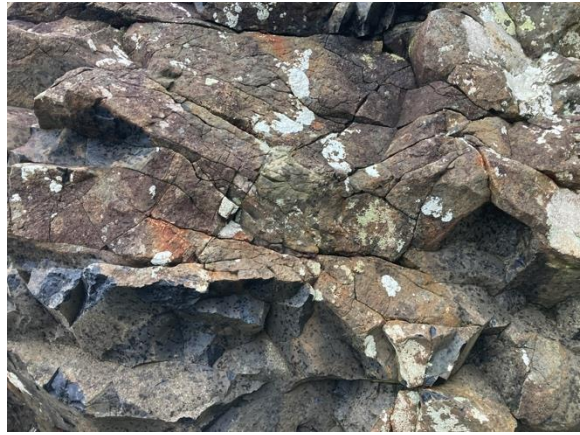
Figure 8 – Area 2 – After

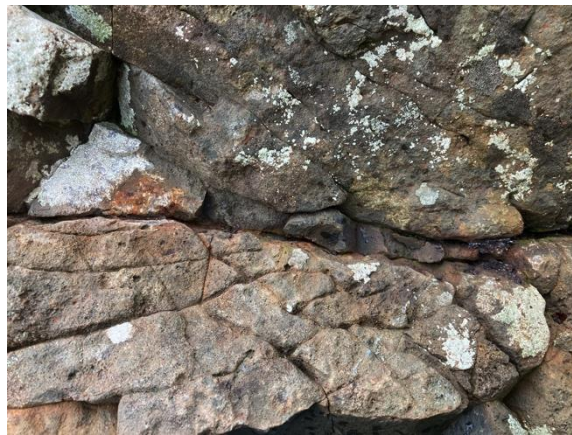
Figure 10 – Area 2 – Detail

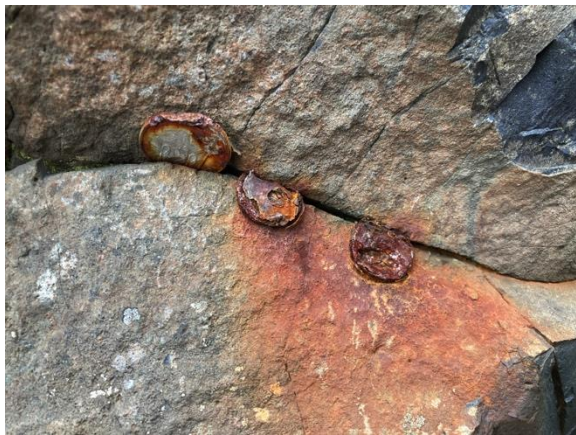
Figure 11 – Area 3 – Before

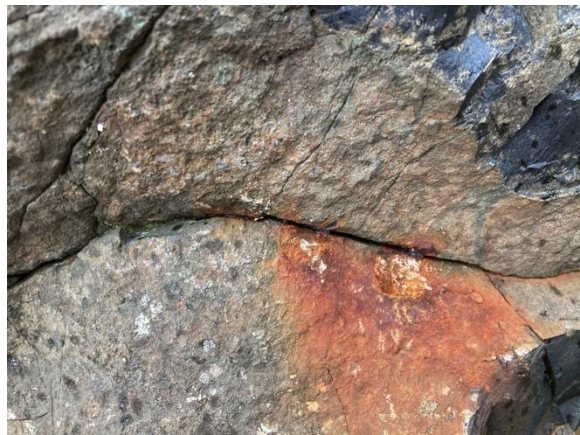
Figure 12 – Area 3 – After.

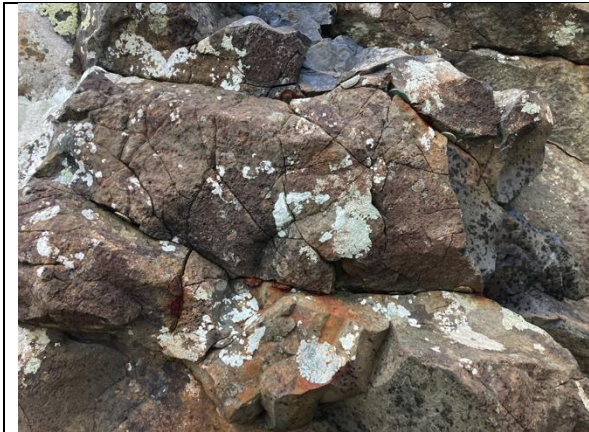
Figure 13 – Area 4 – Before

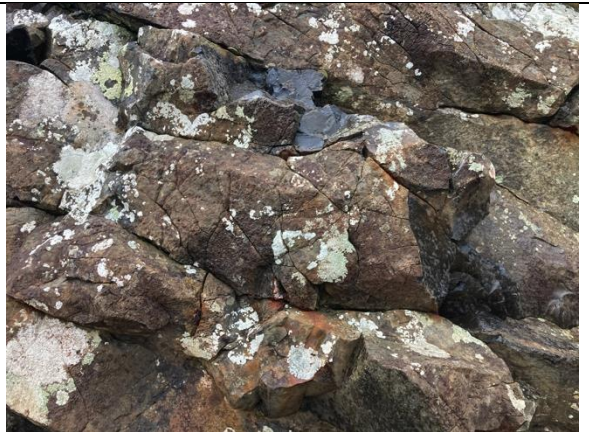
Figure 14 – Area 4 – After

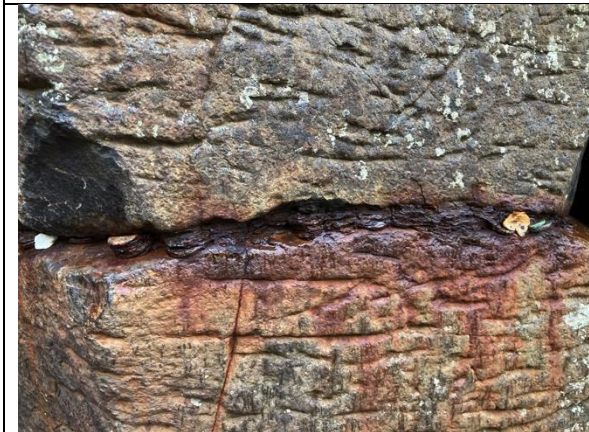
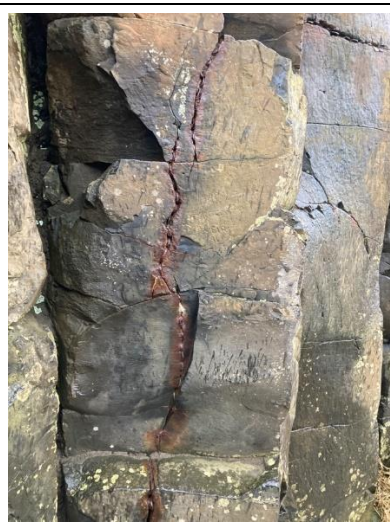
Limitations to this trial were that the area instructed for the trial was not representative of the severity of the corrosion, the difficulty of access (height off the ground and position of the stones) or the compact nature of the coins in other areas, such as in the columns in the area referred to as 'The Gateway'.

Figure 15 and 16 – Details of more severe corrosion and stacked coins found in the columns in The Gateway area.

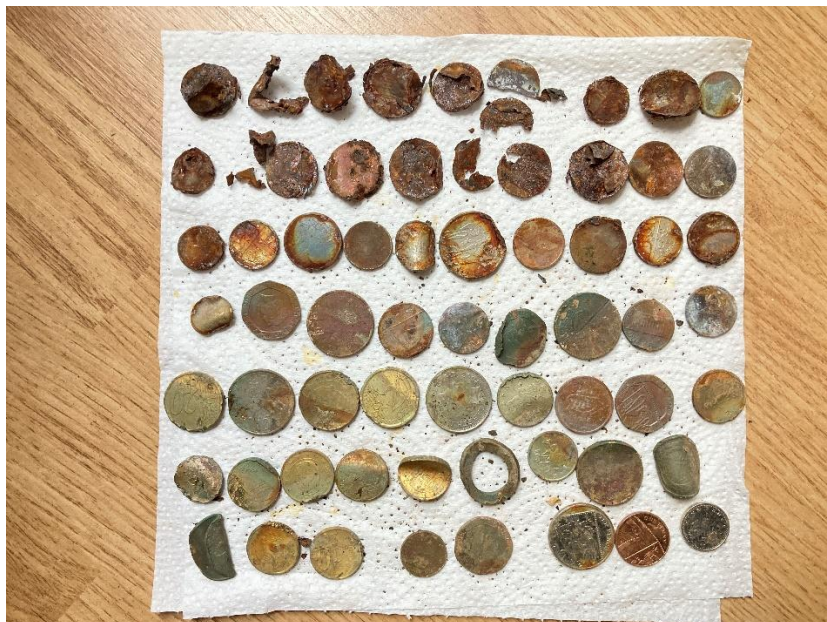
All that did not deteriorate or pull apart in their removal were collected and photographed.

Figure 17 – coins removed

NB The coins were retained and can be posted back to the client on request.
