# Accessibility audits of sites within the Causeway Coast and Glens Heritage Trust area

Improving access for disabled residents and visitors

Prepared by Direct Access Consultancy Limited  
Summer 2021

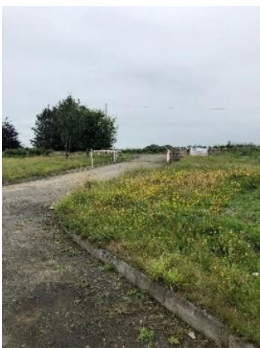
2.	Limepark / Parking Signage

There are no signs to indicate the site or the availability of parking spaces.	<p>There should be a sign at the entrance to the car park to indicate the availability of parking and where any accessible parking spaces are located.</p> <p>Refer to BS8300, A sign or, if appropriate, signs should be provided at the entrance to each car park and at each change in direction to direct disabled motorists to designated parking spaces.</p>	3	A

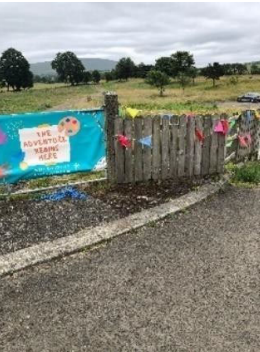
3.	Limepark / Entrance Gate

There is no indication of the pedestrian access via the gate. The gate cannot be independently accessed by all disabled people.	A level pedestrian access route should be provided 1800mm. Any gate to provide minimum 1000mm opening width and should be capable of opening in both directions and of being opened easily with either hand, and should be self-closing.	2	C

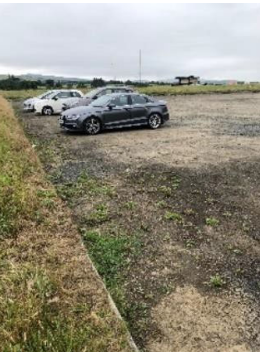
4.	Limepark / Accessible Parking Bays

There are no marked accessible parking bays.	6% of total spaces should be designated accessible parking spaces located as close as possible to facilities. All accessible parking bays should be marked out at least 2.4m wide x 4.8m long plus a 1.2m side transfer zone at the side and end of the bay and the access symbol located in the centre. A sign should be present to the front of each bay with its lower edge 1000 mm above the ground with the words "Blue Badge holders only".	1	C

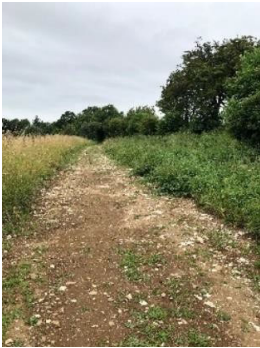
8.	Limepark / Proposed Accessible multi- user path / Surface

Second part of path taken from same spot as no 7	To convert this route to an accessible walk an accessible surface 1800mm wide is recommended. To be accessible path surfaces must be compact, firm, non-slip and obstacle free. Suitable materials include concrete, tarmac, stone, timber and paving.	2	D

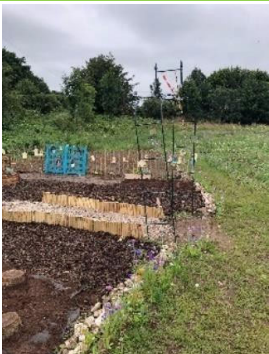
14.	Limepark / Garden Space

Garden space on same walk does not feature any accessible gardening options.	In the event of an accessible footpath being provided consideration should be given to providing accessible gardening option, such as raised beds and suitable surfaced access routes. <a href="https://www.carryongardening.org.uk/files/documents/Raised%20beds%20final%20v08.pdf">https://www.carryongardening.org.uk/files/documents/Raised%20beds%20final No v08.pdf</a>	3	G

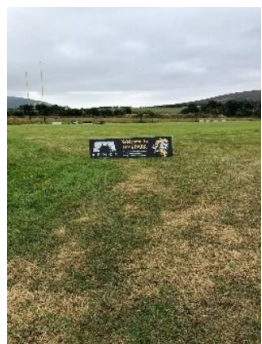
16.	Limepark / Playing Fields / Accessible Viewing

Wheelchair access to watch games on playing fields is only available over grass with some uneven surfaces.	Consideration should be given to providing hard surfacing connected to associated accessible multi-user route to provide wheelchair spaces. Any wheelchair space to be a minimum 1400mm L x 900mm W with minimum 1200mm W connecting access route.	3	D

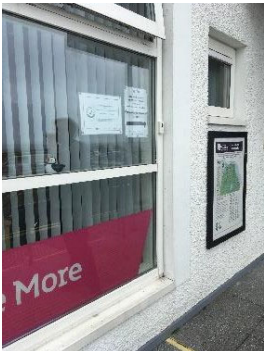
24.	Entrance Door / Doorbell

The doorbell is located too high for wheelchair users or people of short stature to reach. The white of the doorbell does not provide sufficient contrast with the window frame.	The doorbell/call button should be contrasted against its background and relocated at a height of between 900mm and 1100mm.	2	A

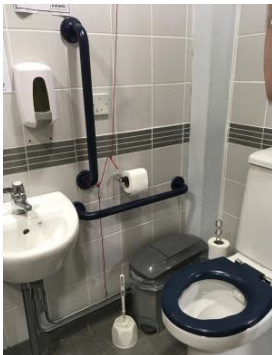
29.	Accessible WC / Call Alarm

<p>The red alarm cord was tied up rendering the system inoperable by someone who is on the floor.</p>	<p>Establish a management procedure to check the functioning of the alarm on a weekly basis and that no cords are tied. Bangles should be located at 800mm and 100mm height. In accordance with BS 8300.</p>	1	M

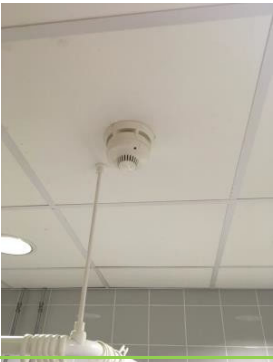
30.	Fire Alarms / Audible & Visual Alert

<p>There does not appear to be any visual strobe or beacon alarms for deaf and hard of hearing people within the accessible toilet facilities.</p> <p>BS8300 - A fire alarm should emit a visual and audible signal to warn occupants with hearing or visual impairments.</p>	A fire alarm should be visible as well as audible to all users. A suitable method of warning should be provided where one or more persons with impaired hearing are anticipated. This method is ideally by providing visual alarm warnings or it can be managed by allocated personnel and management systems.	1	A

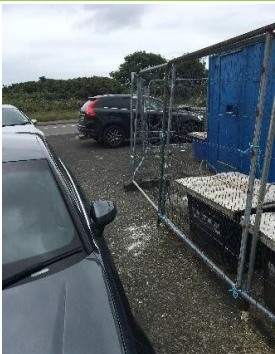
33.	Bonamargy Friary / Accessible Parking

The car park is currently being used for storage for restoration works. When complete parking spaces should be delineated including one accessible parking space.	1x space should be designated as an accessible parking space located as close as possible to facilities. Any accessible parking bays should be marked out at least 2.4m wide x 4.8m long plus a 1.2m side transfer zone at the side and end of the bay and the access symbol located in the centre. A sign should be present to the front of each bay with its lower edge 1000 mm above the ground with the words "Blue Badge holders only".	1	C

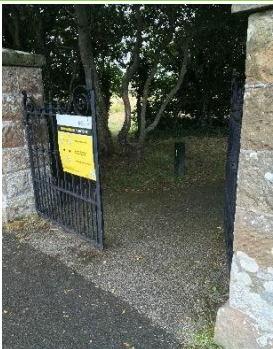
36.	Bonamargy Friary / Gate

The gates at the entrance are manually operated and can be difficult to open.	The gate should provide minimum 1000mm opening width and should be capable of opening in both directions and of being opened easily with either hand, and should be self-closing.	2	C

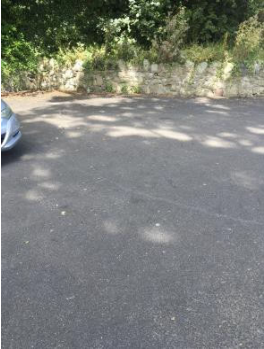
46.	Cushendall Beach / Parking Provision

The car park does not include marked bays for cars accessible or otherwise.	1x space should be designated as an accessible parking space located as close as possible to facilities. Any accessible parking bays should be marked out at least 2.4m wide x 4.8m long plus a 1.2m side transfer zone at the side and end of the bay and the access symbol located in the centre. A sign should be present to the front of each bay with its lower edge 1000 mm above the ground with the words “Blue Badge holders only”.	1	C

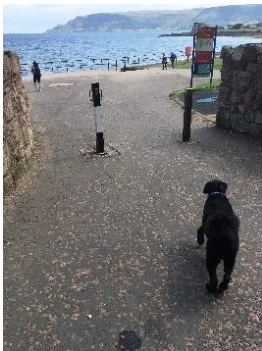
47.	Cushendall Beach / Bollards

Different style bollards on the approach can lead to confusion for people with a visual impairment.	Bollards should be consistent in height, design and contrast. They should be at least 1000mm high and should contrast visually with the background against which they are seen.	3	A

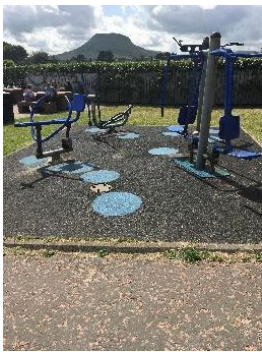
48.	Cushendall Beach / Outdoor Exercise Area

The gym area does not provide an opportunity for disabled people to participate.	Consider adding wheelchair accessible exercise equipment usually in the form of 'Pedal Bike' & 'Lifting'. Ensure that it is located on firm and level ground with generous approaches.

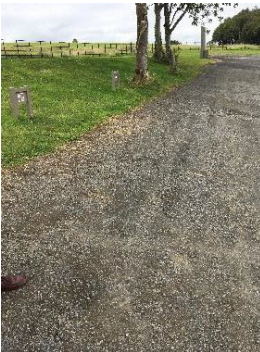
61.	Downhill Demesne / Accessible Parking Bays

Accessible parking spaces are not marked out in accordance with BS 8300.	6% of total spaces should be designated accessible parking spaces located as close as possible to facilities. All accessible parking bays should be marked out at least 2.4m wide x 4.8m long plus a 1.2m side transfer zone at the side and end of the bay and the access symbol located in the centre. A sign should be present to the front of each bay with its lower edge 1000 mm above the ground with the words "Blue Badge holders only".	1	C

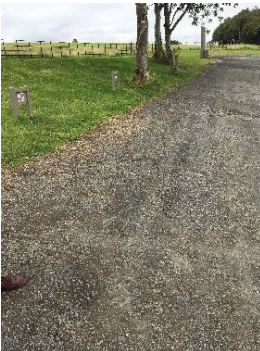
62.	Downhill Demesne / Accessible Signage

The site is a relatively large car park. The accessible parking spaces are near the start of the footpath to the site. There is no information on the availability of accessible restroom facilities which are at the end of the walk/other end of the car park.	Signage should be provided to indicate the availability and location of accessible facilities, such as the Café and toilets.	2	A

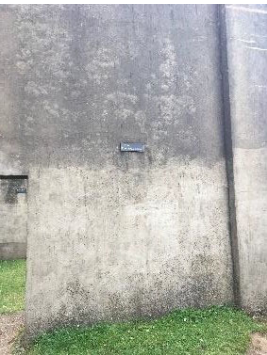
67.	Downhill Demesne / Signage

Signage is small and lacks sufficient contrast with the wall to be effectively seen from the accessible path.	Signs should preferable be placed in a visibility zone 750mm – 2000mm high, where they can be clearly seen from distance and where they can be clearly seen and read from seated and standing positions. Contrast between text and background should be a minimum 30 points difference in LRV (Light Reflectance Value)	2	A

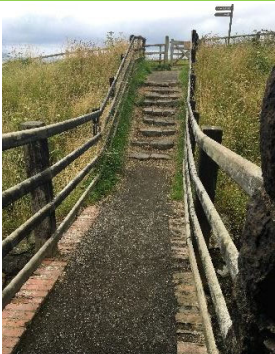
87.	Downhill Demesne / Dovecote Steps / Handrails

Steps to the Dovecot and Ice House are uneven, without handrails and do not feature contrasted nosings.	Subject to heritage constraints BS8300 compliant handrails should be installed to both sides of the steps. These should be well contrasted and not cold to touch. The handrails should have a suitable profile (circular: 40 – 45mm, oval 50mm, in diameter). The handrail should be installed at a height of 900mm and should continue horizontally at least 300mm beyond the top and the bottom steps.	3	B

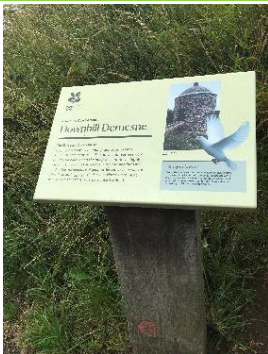
90.	Downhill Demesne / Dovecote / Interpretation

The interpretation panel does not provide information in sign language for Deaf visitors.	QR codes can be added to provide access to interpretation panels. Dynamic QR codes should be used because they can be edited. QR codes should be prominently displayed and advertised to visitors.

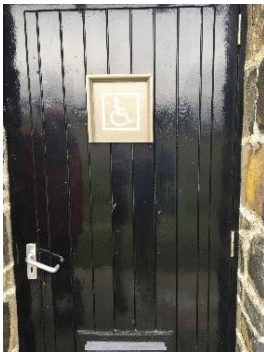
92.	Downhill Demesne / Toilets / Signage

Accessible WC signage does not provide sufficient contrast and is not tactile.	Accessible door signage should feature tactile signage including Braille. All accessible WC door signage to be accessible to all disabled people with Braille and embossed lettering preferred.  	2	A

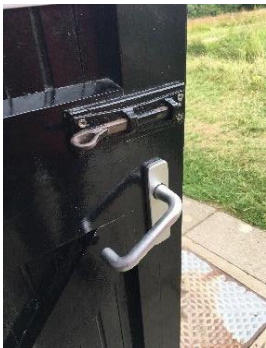
94.	Downhill Demesne / Toilets / Accessible WC / Door Lock

The thumb-lock is not accessible to disabled people that may have limited strength and dexterity.	The door lock should be capable of being operated using a closed-fist and located at a height of 900mm and in line with the handle or at least within 72mm of the handle.	3	A

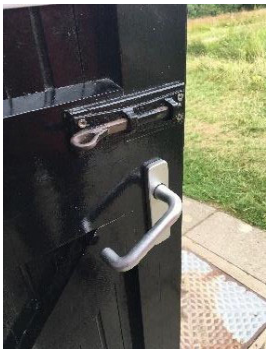
95.	Downhill Demesne / Toilets / Accessible WC / Pull Handle

The thumb-lock is not accessible to disabled people that may have limited strength and dexterity.	The door lock should be capable of being operated using a closed-fist and located at a height of 900mm and in line with the handle or at least within 72mm of the handle.	3	A

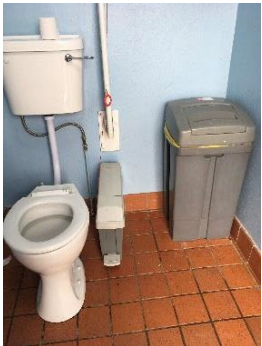
99.	Downhill Demesne / Toilets / Accessible WC / Backrest

The pan does not feature a backrest.	A fixed horizontal rail, with a padded backrest, should be located behind, and centred on, the WC pan when the cistern is not present immediately behind the WC pan.	2	A

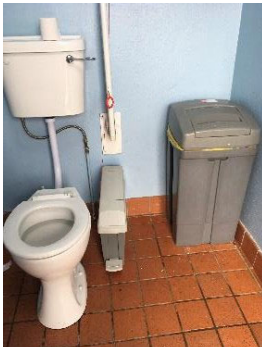
100.	Downhill Demesne / Toilets / Accessible WC / Grabrails

A grab-rail should be provided alongside the drop-down grab-rail.	A vertical grab rail should be present alongside the drop-down rail to comply with best practice.  Refer to TB R & BS8300 for guidance.	2	A

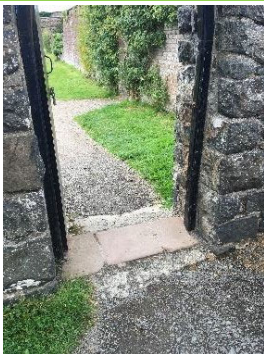
108.	Downhill Demesne / Access Routes / Surface

On the day of the visit a wheelchair user commented it was hard to navigate over gravel and uncertain where the facility was.	The access routes should be reviewed, and consideration given to replacing the gravel surface on key routes to accessible facilities. On these routes a compacted or hard surface should be provided that is relatively smooth, level and slip-resistant.	2	D

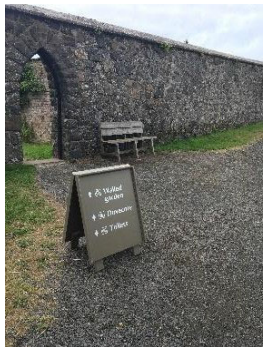
109.	Downhill Demesne / Access Routes / Seating

Seating provided is not to an accessible standard and is located in areas that are not accessible to some disabled people.	Seating should be located on firm and level ground in an area that will not obstruct adjoining access routes. Provide benches with a backrest and armrests. Ensure that the armrests are well contrasted and that there is a space either side of the seat so that a wheelchair user can park alongside a seated companion.  Refer to BS 8300 specification below.	2	B

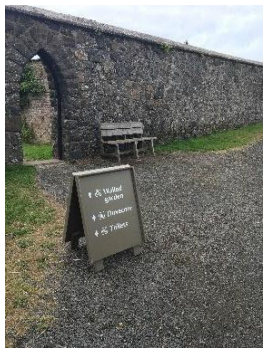
110.	Downhill Demesne / Access Routes / Seating

Seating provided is not to an accessible standard and is located in areas that are not accessible to some disabled people.	1) There should be a variety of seat heights, ranging from 380 mm to 580 mm, within which a height of 480 mm is suitable for wheelchair users. 2) Armrests should be provided to help people lower themselves onto the seat and stand up. 3) Where the seat is set at a height suitable for wheelchair users, armrests should not be set in so as not to restrict the lateral transfer from a wheelchair 4) A supportive back-rest should be incorporated for at least 50% of the length of the seat.	2	B

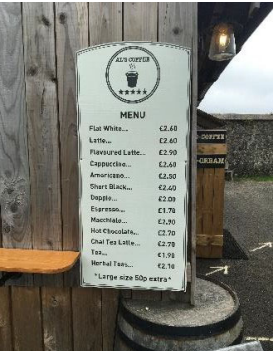
113.	Downhill Demesne / Café / Menu

Café menu is text based. No alternative formats available.	Large print and Braille should be provided. Alternatively, staff should offer to read the menu out loud or have it available on the website so that it can be accessed on personal electronic devices.	3	A

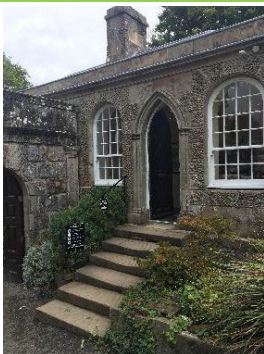
116.	Downhill Demesne / Bishops Gate / Coffee Shop Access

The coffee shop is via steps – there is no alternative means of access.	Subject to heritage constraints the viability of offering level access to the café should be assessed over the long-term.	2	G

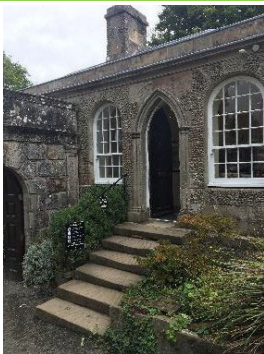
117.	Downhill Demesne / Bishops Gate / Coffee Shop Service

The coffee shop is via steps – there is no alternative means of access.	In the short to medium-term and assistance bell should be provided at the foot of the steps to allow disabled people to summon attention and have requirements met in an accessible area.

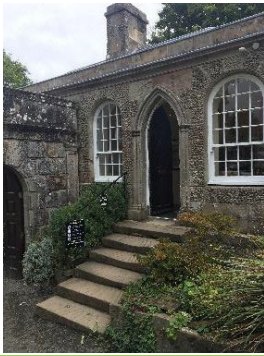
118.	Downhill Demesne / Bishops Gate / Coffee Shop Steps

Steps to the coffee shop do not feature contrasted nosings.	Subject to associated heritage constraints some contrasted nosing should be present. The contrasting material should extend 50 mm to 65 mm in width from the front edge of the tread and 30 mm to 55 mm from the top of the riser and should contrast visually with the remainder of the tread and riser.	3	A

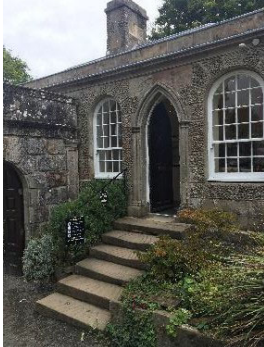
119.	Downhill Demesne / Bishops Gate / Coffee Shop Steps

Steps to the coffee shop do not feature appropriate handrails to both sides.	Subject to heritage constraints BS8300 compliant handrails should be installed to both sides of the steps. These should be well contrasted and not cold to touch. The handrails should have a suitable profile (circular: 40 – 45mm, oval 50mm, in diameter). The handrail should be installed at a height of 900mm and should continue horizontally at least 300mm beyond the top and the bottom steps.	3	B

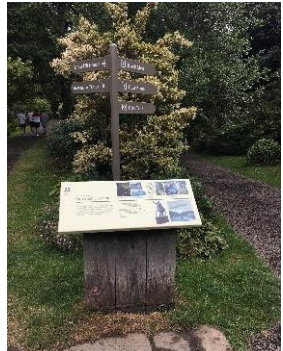
122.	Downhill Demesne / Bishops Gate / Interpretation

The interpretation panel does not provide information in sign language for Deaf visitors.	QR codes can be added to provide access to interpretation panels. Dynamic QR codes should be used because they can be edited. QR codes should be prominently displayed and advertised to visitors.

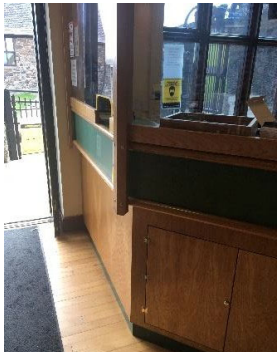
137.	Dunluce Castle / Reception / Screen

The security screen has glare which can be difficult for deaf and hard of hearing people to lipread.	Reception or service points should be located where the ability of a person to lip read is not adversely affected, e.g., by the presence of windows, glazed screens or mirrors behind the service point. Reception counters and service points should not be placed in front of backgrounds which are patterned.	2	B

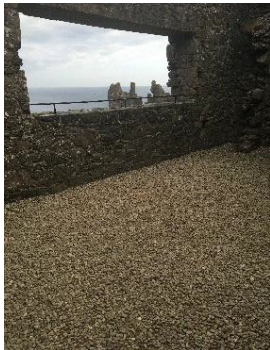
145.	Dunluce Castle / / Alternative Interpretation

An interpretation opportunity overlooks the sea and cliff which is accessed. Handrails can be used to provide Braille interpretation.	Consider using Braille on handrail to provide alternative accessible interpretation. For reference see <a href="https://www.news18.com/news/buzz/braille-inscription-railing-naples-castle-wall-italy-scenic-view-blind-people-4068731.html">https://www.news18.com/news/buzz/braille-inscription-railing-naples-castle-wall-italy-scenic-view-blind-people-4068731.html</a>	3	B

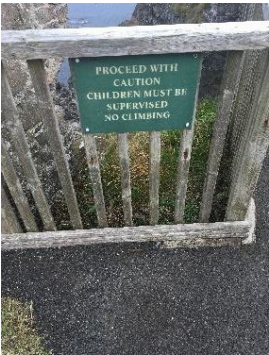
148.	Dunluce Castle / Steep Access Routes

Steep access routes are present at the site that provide the only access to some popular areas.	Subject to heritage constraints, consideration should be given to providing wooden TB R compliant steps and handrails to improve access to these areas.	2	C

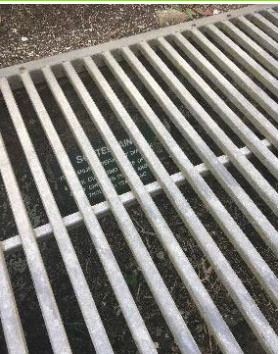
153.	Dunluce Castle / Signage Interpretation Location

Some signage pertaining to the site is covered by drainage. This makes it difficult to read.	Interpretation panels should be located in visible areas that can provide a clear 1500mm x 1500mm approach over firm, level and slip-resistant surfaces that are directly connected to an adjoining accessible access route 1500mm wide.	3	B

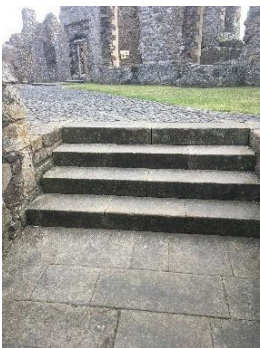
156.	Dunluce Castle / Alternative Access & Interpretation

The key areas of the site can only be access by steps. Provide a panel, video or similar, at an accessible location. This will provide alternative interpretation to show the same key features and views that can be gained by visitors able to explore the ruins independently.	Any alternative interpretation provided must be available in accessible formats, such as tactile, audio, Braille.	2	G

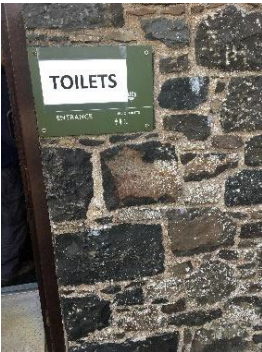
160.	Dunluce Castle / Toilets / Signage

The signage for the toilet does not feature recognisable symbols to identify their use.	<p>Toilet door signage should feature tactile signage including correct symbols and Braille. All accessible WC door signage to be accessible to all disabled people with Braille and embossed lettering p</p>

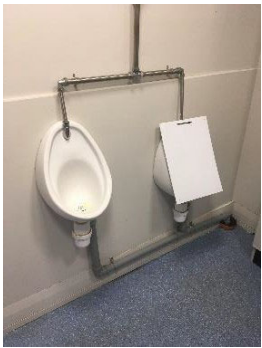
The urinal does not feature a grab rail.	A well contrasted grab rail should be provided to both sides of one urinal in every WC where applicable.	3	A

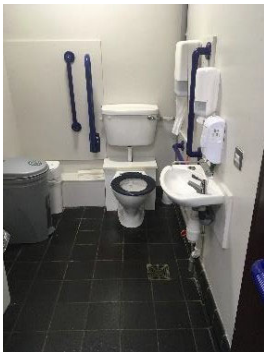
163.	Dunluce Castle / Accessible WC / Mirror

A mirror should be provided.	A full-length mirror should be present at a height between 600mm - 1600mm located away from the handbasin in accordance with BS8300.	2	A

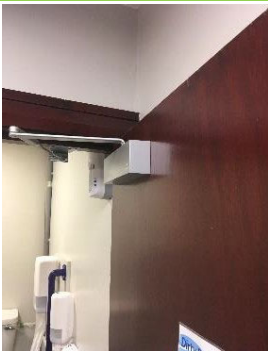
165.	Dunluce Castle / Accessible WC / Door Closer

A door closer is fitted to the door. Closers make doors difficult to open and restrict the manoeuvrability available for disabled people within small areas such as Accessible WCs.	Closer to be removed and door to provide smooth and easy opening action requiring a maximum 30 Newton of force.	2	A

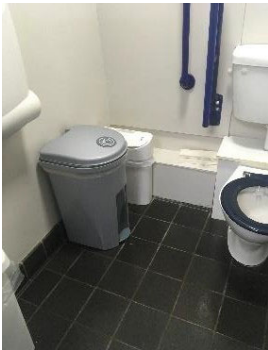
166.	Dunluce Castle / Accessible WC / Transfer Zone

The bin is in the transfer zone which restricts the manoeuvring space available to wheelchair users.	Accessible WC must be regularly inspected in order to maintain the transfer zone alongside the WC free of obstructions. Bins and other items can prevent wheelchair users from approaching and transferring.	1	M

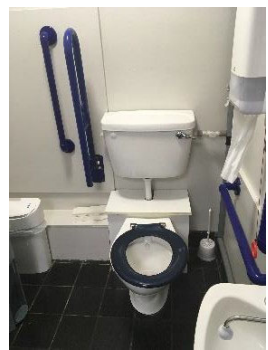
167.	Dunluce Castle / Accessible WC / Back Rest

There is no backrest provided.	A fixed horizontal rail, with a padded backrest, should be located behind, and centred on, the WC pan when the cistern is not present.  Refer to TB R & BS8300 for guidance.	2	A

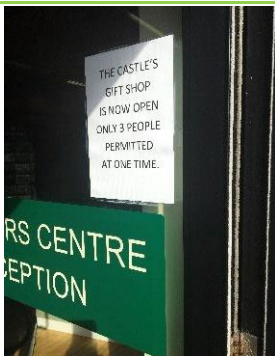
172.	Dunluce Castle / Visitor Centre / Temporary Notices

Temporary notices are all capitalised which do not conform to best practice.	Implement a management procedure to ensure that any temporary notices are typed out using a mixture of lower case and upper case lettering. According to best practice, words entirely in upper case type (capital) should be avoided. A sans serif type face with a relatively large "capital" height to "x" height should be used.	2	M

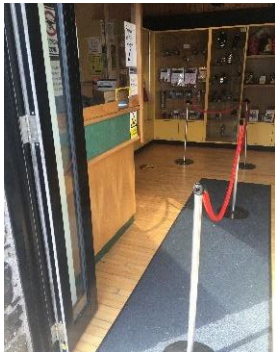
173.	Dunluce Castle / Visitor Centre / Barriers

Rope barriers can be difficult for Blind and partially sighted people to see and detect due to the space beneath being beyond the arc of a detection cane.	It is often easier to fill the void beneath barriers with signage, seating, planting or similar that will provide guarding at a low level.	2	M

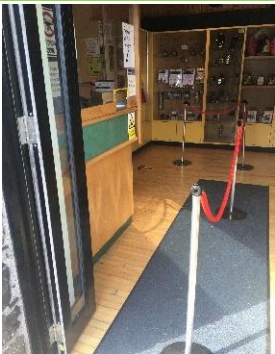
174.	Dunluce Castle / Visitor Centre / Barriers / Access Routes

Rope barriers do not appear to offer sufficient space to allow access by all disabled people.	Access routes should allow a minimum aisle width of 1200mm with 1800mm diameter turning space for a turn or return. If these dimensions cannot be implemented due to space or COVID restrictions staff must be prepared to move the barriers to allow access.	3	M

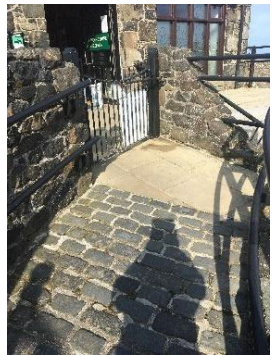
178.	Dunluce Castle / Visitor Centre / Approach / Gate

The gates at the entrance are manually operated and can be difficult to open.	The gate should provide minimum 1000mm opening width and should be capable of opening in both directions and of being opened easily with either hand, and should be self-closing.	2	B

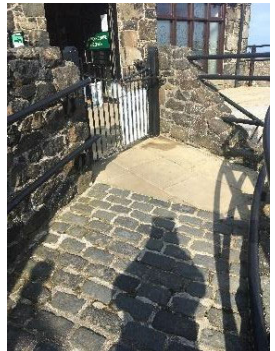
179.	Dunluce Castle / Visitor Centre / Approach / Surface

Cobbled surfaces are not considered accessible for disabled people.	Subject to heritage considerations consideration should be given to providing a 1200mm width smooth, level and slip-resistant surface underfoot.	3	C

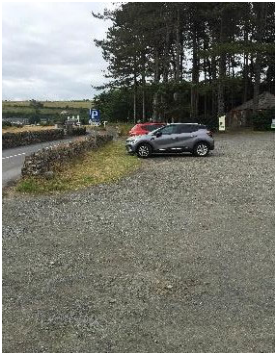
193.	Cushendun / Car Park / Accessible Parking Bays

There are no marked accessible parking bays.	6% of total spaces should be designated accessible parking spaces located as close as possible to facilities. All accessible parking bays should be marked out at least 2.4m wide x 4.8m long plus a 1.2m side transfer zone at the side and end of the bay and the access symbol located in the centre. A sign should be present to the front of each bay with its lower edge 1000 mm above the ground with the words "Blue Badge holders only".	1	C

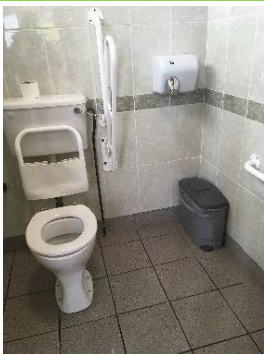
197.	Cushendun / Car Park / Toilets / Accessible WC / Grab-rails

Grab-rail is not present on the closed side of the WC pan closest to WC. The horizontal grab-rail is located on the open side where it cannot be used for transfer to the WC.	Horizontal 600mm grab-rail to be provided on the closed side of the WC pan 250mm from back wall at a height of 680mm.  Refer to TB R & BS8300 for guidance.	1	A

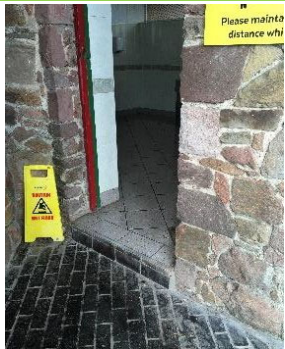
200.	Cushendun / Car Park / Toilets / Step

The standard toilet facility has a stepped entrance.	Level access should be available to all toilets to allow all disabled people equality of choice.	3	B
201.	Cushendun / Car Park / Toilets / Step

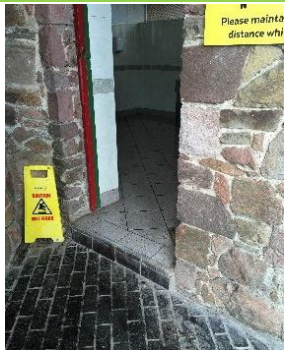
Step nosing is not contrasted and could be a hazard for Blind and partially sighted people.	Contrasted nosing should be present. The contrasting material should extend 50 mm to 65 mm in width from the front edge of the tread and 30 mm to 55 mm from the top of the riser and should contrast visually with the remainder of the tread and riser.	3	A
202.	Cushendun / Car Park / Toilets / Urinals

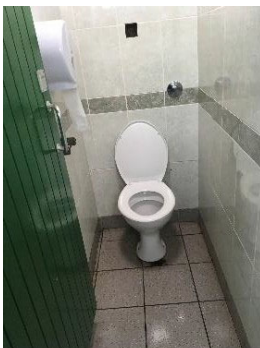
204.	Cushendun / Car Park / Toilets / Ambulant Toilet

<p>There are no grab rails for ambulant users who may not be able to access the accessible facility if it is in use by others.</p>	<p>As the toilets throughout the site are refurbished, there should be an internal standard or set of guidelines. These should state that any toilet being refurbished should be checked for the feasibility of including a cubicle for ambulant disabled persons. Any ambulant disabled cubicle provided should be TB R compliant.</p>	2	C

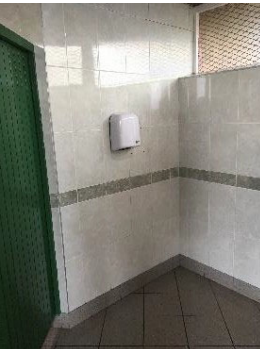
205.	Cushendun / Car Park / Toilets / Contrast

<p>To help blind and partially sighted people identify key objects within sanitary accommodation, support rails and grab rails should contrast visually with the wall, the WC seat and cover should contrast visually with the WC pan and cistern, and sanitary fittings and accessories should contrast visually with the background against which they are seen.</p>	<p>Greater contrast should be considered during any repair, replacement or refurbishment, for the fixtures and fittings within the WCs. This can be achieved by having light sanitary ware seen against a dark background or vice versa.</p>	3	G

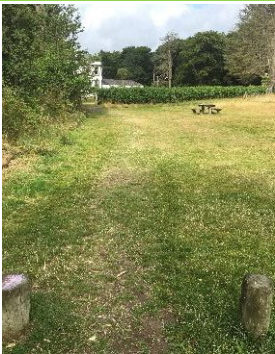
209.	Cushendun / Glenmona House / Path

Mown grass surfaces are not considered accessible to all disabled people due to the variable condition and slip-resistance of the surface in different weather conditions.	To convert this route to an accessible walk an accessible surface 1800mm wide is recommended. To be accessible path surfaces must be compact, firm, non-slip and obstacle free. Suitable materials include concrete, tarmac, stone, timber and paving.	3	C

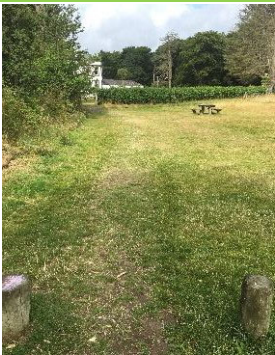
210.	Cushendun / Glenmona House / Accessibility Information

Path from car park to Glenmona House. Disabled people who have informed management in advance are able to park in front of the house itself.	The most immediate available information on <a href="https://www.nationaltrust.org.uk/cushendun/features/glenmona-house-one-of-the-big-houses-of-cushendun">https://www.nationaltrust.org.uk/cushendun/features/glenmona-house-one-of-the-big-houses-of-cushendun</a> did not provide relevant contact information to arrange parking. Website should be updated to provide relevant accessibility information.	1	M

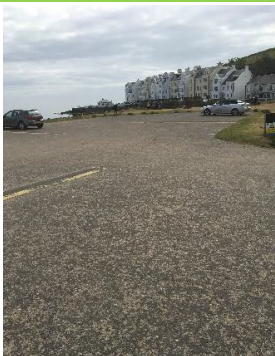
211.	Cushendun / Village / Car Park / Accessible Bays

Village car park also does not have parking bays marked out.	6% of total spaces should be designated accessible parking spaces located as close as possible to facilities. All accessible parking bays should be marked out at least 2.4m wide x 4.8m long plus a 1.2m side transfer zone at the side and end of the bay and the access symbol located in the centre. A sign should be present to the front of each bay with its lower edge 1000 mm above the ground with the words "Blue Badge holders only".	1	C

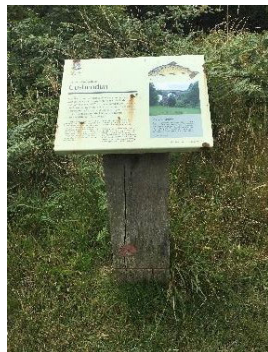
219.	Cushendun / Village / Riverside Walk / Interpretation

The interpretation panel is on uneven ground.	Interpretation panels should be located in visible areas that can provide a clear 1500mm x 1500mm approach over firm, level and slip-resistant surfaces that are directly connected to an adjoining accessible access route 1500mm wide.	2	B

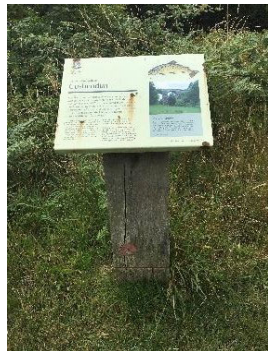
220.	Cushendun / Village / Riverside Walk / Interpretation

The interpretation panel does not provide any information for visitors with a visual or hearing impairment.	Many disabled people carry devices, such as Tablets and phones, that are customised to meet their personal access requirements. Providing interpretation through these devices is a great way of ensuring that disabled people have access to BSL, subtitles and audio information.	2	C

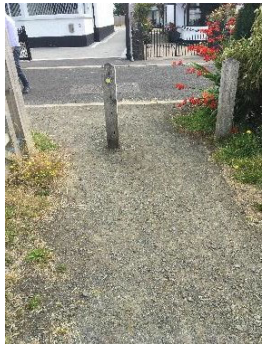
222.	Cushendun / Village / Riverside Walk / Signage

Wayfinding needs to be reviewed as in some places arrows were leading into dead ends or private property and not the route of public access.	Signage should be provided to indicate: features that affect accessibility: <ul style="list-style-type: none"> <li>• Distance</li> <li>• Access barriers (e.g. gates and stiles)</li> <li>• Width of path</li> <li>• Longitudinal gradient</li> <li>• Cross gradient</li> <li>• Surface roughness</li> <li>• Presence of steps</li> </ul>	1	B

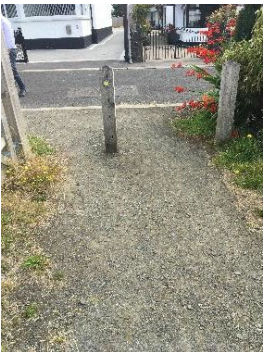
223.	Cushendun / Village / Riverside Walk / Signage

Wayfinding needs to be reviewed as in some places arrows were leading into dead ends or private property and not the route of public access.	Any changes to signage should be consistent and part of a wide external wayfinding review required to allocate signage that features details of distances, gradients, steps, toilets etc and destination and accessibility of route.	1	C

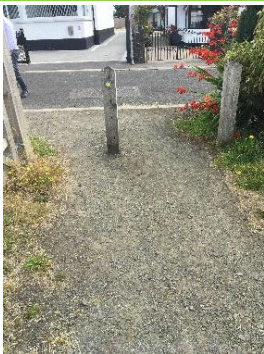
224.	Cushendun / Village / Riverside Walk / Wooden Bollards

Grey bollards on grey background presents poor contrast that may cause difficulty and present a collision hazard to Blind/partially sighted people.	Add colour contrast to the bollards to ensure that they are easily distinguishable against the background upon which they are seen. BS8300 - Low-level posts, e.g. bollards, should not be located within an access route. they should be at least 1000 mm high and should contrast visually with the background against which they are seen (it is desirable also to incorporate a 150 mm deep contrasting strip at the top).	3	A

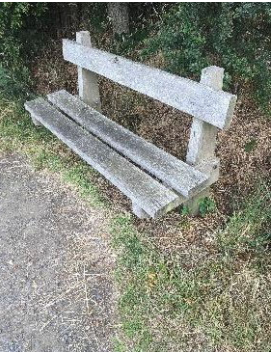
225.	Cushendun / Village / Riverside Walk / Seating

Access for disabled people can be improved by additional seating being provided particularly at the top and bottom of steeper inclines.	Resting points could be provided no more than 100m apart and particularly on steep access routes. Any seating provided should be placed clear of access routes with seating and tactile cues.	2	C

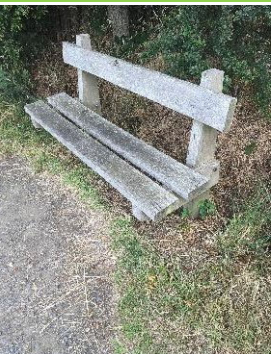
226.	Cushendun / Village / Riverside Walk / Seating

Seating provided is not to an accessible standard and is located in areas that are not accessible to some disabled people.	Seating should be located on firm and level ground in an area that will not obstruct adjoining access routes. Provide benches with a backrest and armrests. Ensure that the armrests are well contrasted and that there is a space either side of the seat so that a wheelchair user can park alongside a seated companion.  Refer to BS 8300 specification below.	2	B

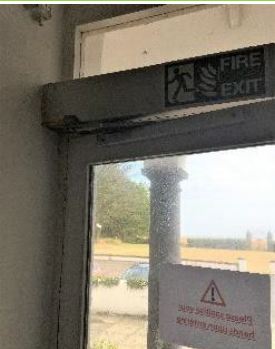
233.	Glenmona House / Entrance / Powered Door

The electrical cable or unit to control the automatic door has been removed. Reinstating this will enable the door to be operated again.	Door to be repaired to ensure that it is in working order for disabled people that require it to access public spaces in the house during opening hours.	1	A
234.	Glenmona House / Entrance / Door Button

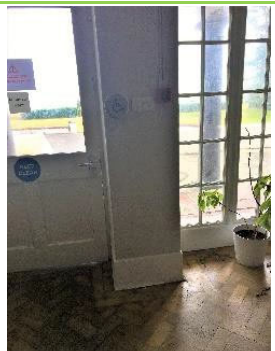
The button for the door is too high. It is confusing as it implies that the automatic door does work.	Both internal and external buttons should be covered whilst the door is not operational.	1	M
235.	Glenmona House / Entrance / Door Button

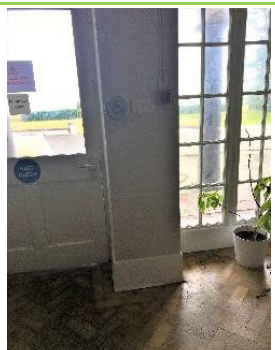
The button for the door is too high. It is confusing as it implies that the automatic door does work.	Manual activation controls for power-operated pedestrian doors should be located at a height of between 750 mm and 1 000 mm from finished floor level.	3	A

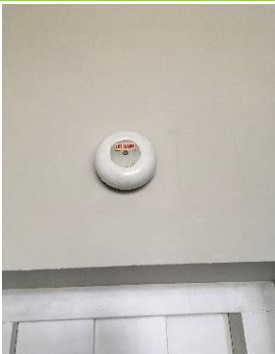
239.	Glenmona House / Fire Alarm

The fire alarm is audible only with no flashing lights.	A suitable method of warning should be provided where one or more persons with impaired hearing are anticipated. This method is ideally by providing visual alarm warnings or it can be managed by allocated personnel and management systems.	2	M

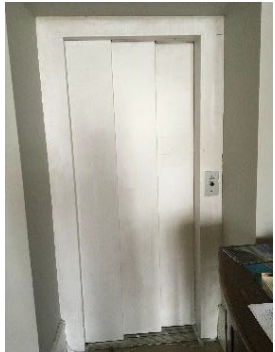
240.	Glenmona House / Lift

Lift was out of order on day of visit as due for a service.	Lifts need to be fit for purpose at all times and regularly serviced. Site management need to ensure that the appropriate procedures are implemented particularly if upper floors are reopened to the public.	1	B

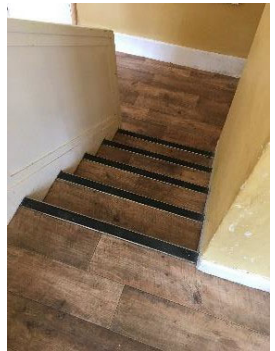
241.	Glenmona House / Stairs

Spaces to the rear of the property are only accessed by stairs.	These areas are currently unoccupied. Care must be taken to ensure that any publicly available services offered in these areas can be replicated in an accessible location to ensure equality of service delivery.	1	M

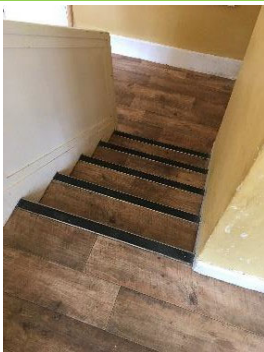
242.	Glenmona House / Stairs / Handrails

The stairs do not feature handrails.	BS8300 compliant handrails should be installed to both sides. These should be well contrasted and not cold to touch. The handrails should have a suitable profile (circular: 40 – 45mm, oval 50mm, in diameter). The handrail should be installed at a height of 900mm and should continue horizontally at least 300mm beyond the top and the bottom steps.	3	B

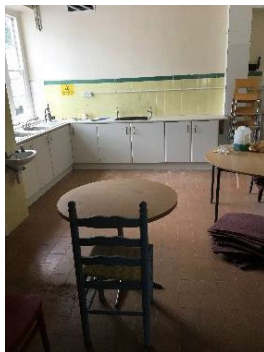
243.	Glenmona House / Kitchen Areas

There are kitchens that are not currently being used but could be recommissioned if the areas are reopened.	It is recommended that the building management considers an in-house standards document for refurbishments which ensures that all staff kitchenettes going forward feature lever style taps, improved contrast and split height worksurfaces.  Refer to TB R & BS8300 for guidance.	2	G

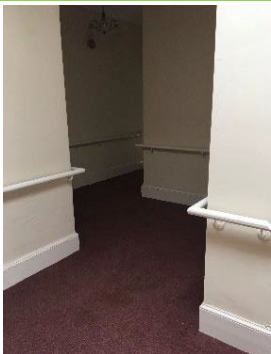
245.	Glenmona House / Grab-rails

Grab rails are white on cream walls which does not provide adequate contrast.	These grabrails should be removed.	2	M

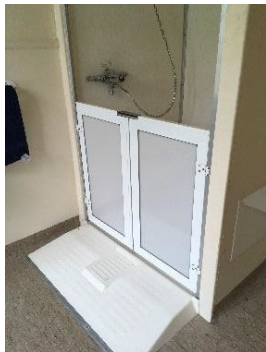
246.	Glenmona House / Shower

A level access shower is available on the top floor. This is rarely used, can only be accessed by lift/stairs, and is not to a full accessible specification.	<p>According to TB R/6.27/28 -“Where a communal shower facility is provided, it should include a wheelchair accessible incorporated shower facility within it. Where there is a shower facility for staff, not less than one individual wheelchair accessible shower room should also be provided.”</p> <p>Provide a TB R compliant Accessible WC in the event of any refurbishment.</p>	1	G

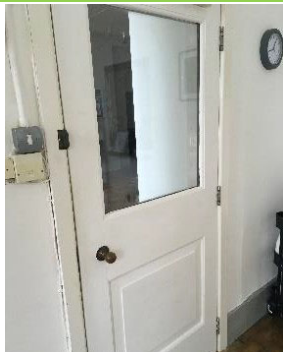
249.	Glenmona House / Doorknobs

Door furniture should be replaced by more accessible lever action handle capable of being operated using a closed-fist.  Deemed fit to retain only if door remains fully open during opening hours.	Door furniture should be replaced by more accessible lever action handle capable of being operated using a closed-fist.  Deemed fit to retain only if door remains fully open during opening hours.	2	A

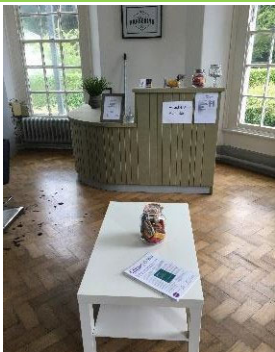
250.	Glenmona House / Hairdresser / Reception

A hearing enhancement system, using induction loop, infrared or radio transmission, should be installed at service or reception counters where the background noise level is high.	Install an induction loop to the reception desk. Install signage indicating the availability of the facility and ensure that staff members are aware in how to use the system. Direct Access supply, install and provide brief training. <a href="https://directaccessgp.co.uk/induction-loops-and-hearingenhancement-systems/">https://directaccessgp.co.uk/induction-loops-and-hearingenhancement-systems/</a>	2	A

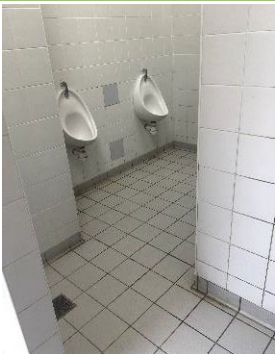
255.	Portrush / Toilets / Urinals

There is no grab rail for ambulant users.	A well contrasted grab rail should be provided to both sides of one urinal in every WC where applicable.	3	A

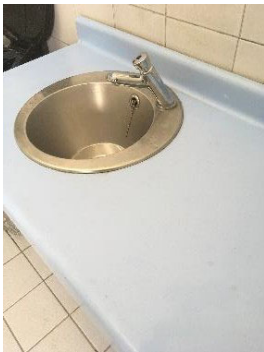
256.	Portrush / Toilets / Taps

Push taps are installed throughout the toilets. These can be very difficult for disabled people to operate.	<p>The push taps should be replaced with lever style, this will aid people with limited dexterity in their wrists.</p> <p>According to BS8300 - Taps should either be mixer taps with an up and down action to control water flow or individual hot and cold lever operated taps with not more than a quarter turn from off to full flow.</p>	2	A

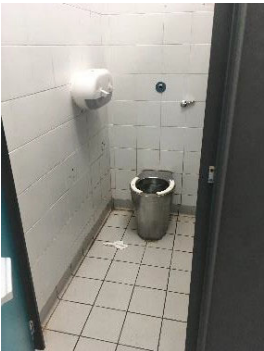
257.	Portrush / Toilets / Ambulant Disabled Cubicle

There are no grab rails for ambulant users who may not be able to access the accessible facility if it is in use by others.	As the toilets throughout the site are refurbished, there should be an internal standard or set of guidelines. These should state that any toilet being refurbished should be checked for the feasibility of including a cubicle for ambulant disabled persons. Any ambulant disabled cubicle provided should be TB R compliant.	2	C

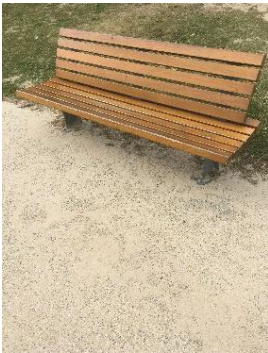
262.	Portrush / Beach / Seating

Seating provided is not to best practice accessible standard and is located in areas that are not accessible to some disabled people.	1) There should be a variety of seat heights, ranging from 380 mm to 580 mm, within which a height of 480 mm is suitable for wheelchair users. 2) Armrests should be provided to help people lower themselves onto the seat and stand up. 3) Where the seat is set at a height suitable for wheelchair users, armrests should not be set in so as not to restrict the lateral transfer from a wheelchair 4) A supportive back-rest should be incorporated for at least 50% of the length of the seat.	2	B

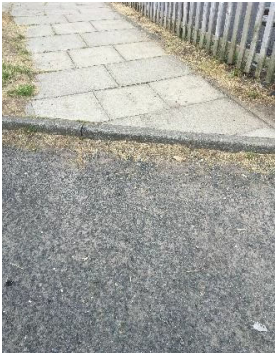
270.	Waterfoot / Access Route / Kerb

The pavement is not flush with the car park.	Flush dropped-kerbs should be installed to provide a firm, level, and slip-resistant access point.	1	A

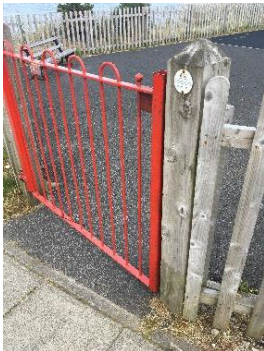
271.	Waterfoot / Playground / Gate

The gate to the playground area in the southern car park requires reaching over the gate to operate the controls which may be difficult for people unable to grip the handle.	Any side-hung gate on an accessible route should be capable of opening in both directions and of being opened easily with either hand, and should be self-closing. The catch to any gate should not require the user to have to pinch or twist their hand to operate and should be capable of being opened using a closed-fist.	2	A

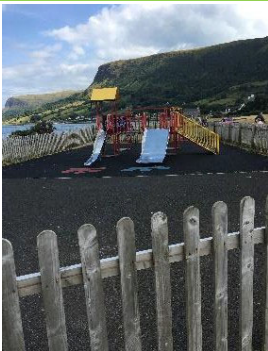
272.	Waterfoot / Playground / Equipment

The playground equipment can be improved to offer more play opportunities for disabled people. It may be possible to improve the playground during future works.	The playground should include several accessible ground levels with visual, audible, and tactile sensory play opportunities. Dynamic pieces should be within easy reach from seated and standing positions. Quiet areas of retreat and gentle sensory experiences should also be provided.	2	D

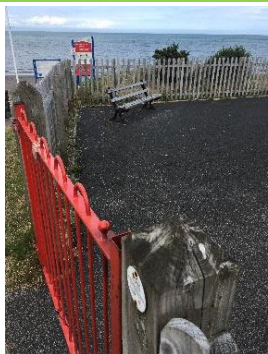
273.	Waterfoot / GENERAL / Seating

Seating provided is not to best practice accessible standard and is located in areas that are not accessible to some disabled people.	Seating should be located on firm and level ground in an area that will not obstruct adjoining access routes. Provide benches with a backrest and armrests. Ensure that the armrests are well contrasted and that there is a space either side of the seat so that a wheelchair user can park alongside a seated companion.  Refer to BS 8300 specification below.	2	B

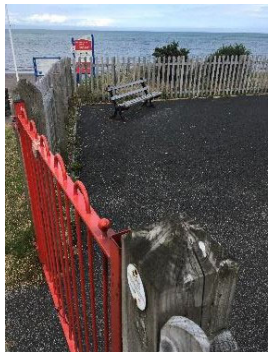
274.	Waterfoot / GENERAL / Seating

Seating provided is not to best practice accessible standard and is located in areas that are not accessible to some disabled people.	1) There should be a variety of seat heights, ranging from 380 mm to 580 mm, within which a height of 480 mm is suitable for wheelchair users. 2) Armrests should be provided to help people lower themselves onto the seat and stand up. 3) Where the seat is set at a height suitable for wheelchair users, armrests should not be set in so as not to restrict the lateral transfer from a wheelchair 4) A supportive back-rest should be incorporated for at least 50% of the length of the seat.	2	B

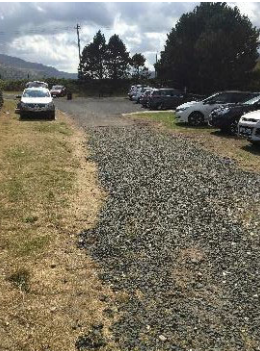
280.	Waterfoot / Beach Café / Car Park / Accessible Bays

The car park nearest the beach café does not have accessible parking bays marked out.	1x space should be designated as an accessible parking space located as close as possible to facilities. Any accessible parking bays should be marked out at least 2.4m wide x 4.8m long plus a 1.2m side transfer zone at the side and end of the bay and the access symbol located in the centre. A sign should be present to the front of each bay with its lower edge 1000 mm above the ground with the words "Blue Badge holders only".	1	C

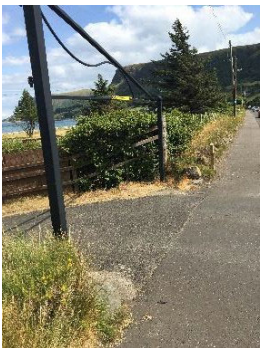
281.	Waterfoot / Beach Café / Car Park / Signage

There are no signs at the entrance to indicate the presence of parking facilities.	There should be a sign at the entrance to the car park to indicate parking and any accessible parking spaces.  Refer to BS8300, A sign or, if appropriate, signs should be provided at the entrance to each car park and at each change in direction to direct disabled motorists to designated parking spaces.	2	A

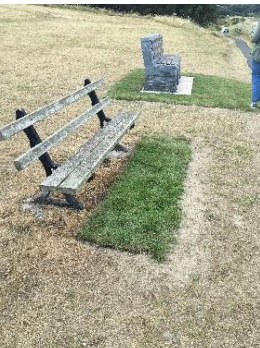
282.	Waterfoot / GENERAL / Seating

Seating provided is not to a best practice accessible standard and is located in areas that are not accessible to some disabled people.	Seating should be located on firm and level ground in an area that will not obstruct adjoining access routes. Provide benches with a backrest and armrests. Ensure that the armrests are well contrasted and that there is a space either side of the seat so that a wheelchair user can park alongside a seated companion.  Refer to BS 8300 specification below.	2	B

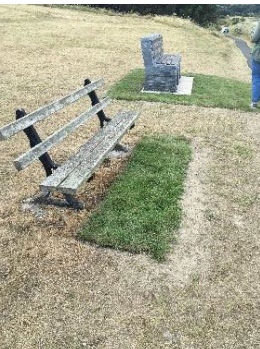
283.	Waterfoot / GENERAL / Seating

Seating provided is not to an accessible standard and is located in areas that are not accessible to some disabled people.	1) There should be a variety of seat heights, ranging from 380 mm to 580 mm, within which a height of 480 mm is suitable for wheelchair users. 2) Armrests should be provided to help people lower themselves onto the seat and stand up. 3) Where the seat is set at a height suitable for wheelchair users, armrests should not be set in so as not to restrict the lateral transfer from a wheelchair 4) A supportive back-rest should be incorporated for at least 50% of the length of the seat.	2	B

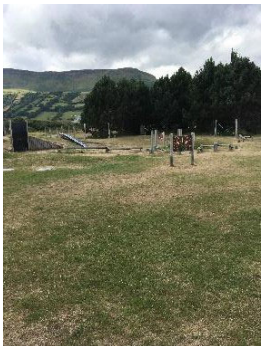
284.	Waterfoot / Café Area / Playground

The playground equipment can be improved to offer more play opportunities for disabled people. It may be possible to improve the playground during future works.	The playground should include several accessible ground levels with visual, audible, and tactile sensory play opportunities. Dynamic pieces should be within easy reach from seated and standing positions. Quiet areas of retreat and gentle sensory experiences should also be provided.	2	D

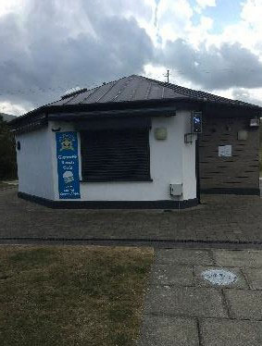
285.	Waterfoot / Café Area / Accessible WC / Signage

The signs from the southern car park indicate that this is the location of the accessible restroom – no facilities are here.	Signage review urgently required to ensure that disabled people are not misdirected. The Accessible WC is located in the North East car park and should not be confused with the Café facilities.	1	A

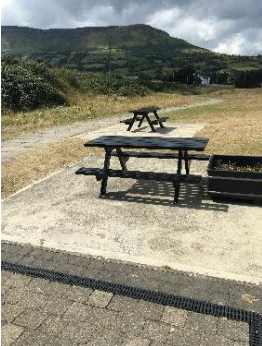
286.	Waterfoot / Café Area / Picnic Area

Standard table & seating may not provide good access for all disabled people. Wheelchair users will require clear space beneath.	A range of table heights should be available, with the clear space to the underside of the tables between 700mm and 800mm. Any accessible tables should be located on a hard surface that can provide an 1800mm x 1800mm approach.	2	A

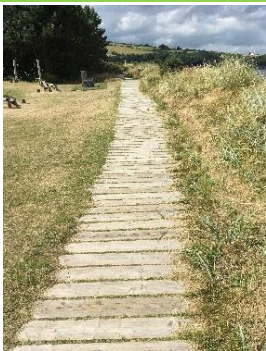
289.	Waterfoot / Boardwalk

From the café area the boardwalk changes style heading towards the village.	The boardwalk provides a reasonable accessible surface but should be subject to maintenance to ensure an unobstructed width of 1000mm – 1200mm. The largest break in the surface of the path should be no more than 12mm measured along the line of the path.	2	M

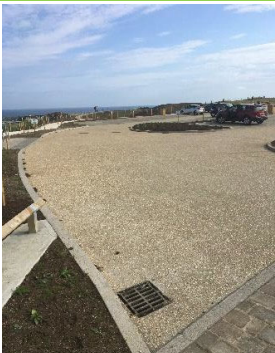
No:	Item	Identification	Comment	Recommendation	Priority	Cost Band
300.	Dunluce & Maghercross / Parking / Signage

<p>Dunluce &amp; Maghercross viewing site recently opened.</p> <p>There were no signs to indicate the location of the accessible parking spaces.</p>	<p>There should be a sign at the entrance to the car park to indicate parking and any accessible parking spaces.</p> <p>Refer to BS8300, A sign or, if appropriate, signs should be provided at the entrance to each car park and at each change in direction to direct disabled motorists to designated parking spaces.</p>	2	A

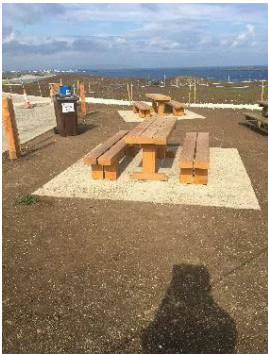
304.	Dunluce & Maghercross / Picnic Area Access

The picnic tables were only accessed by crossing compacted earth.	Provide a picnic table in an area with an access route that has a firm, level and slip-resistant surface. A range of table heights should be available, with the clear space to the underside of the tables between 700mm and 800mm. Seating should be contrasted and accommodate a variety of seat heights at 380mm, 480mm and 580mm with some seating available with both back support 300mm from seat level and armrests.	2	B
305.	Dunluce & Maghercross / Picnic Area Access

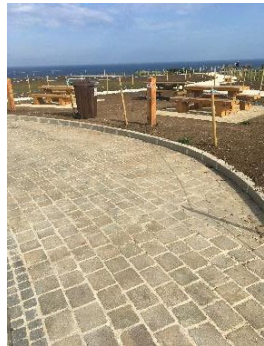
Lack of dropped kerb to picnic area.	Flush dropped-kerbs should be installed to provide a firm, level, and slip-resistant access point.	1	A
